6.2 Damage to Wood Houses

6.2.1 Objectives of damage survey

A lot of wood buildings were damaged by the 2011 Tohoku earthquake. NILIM and BRI surveyed the damage of wood building starting from March 14, three days after the earthquake occurrence for the purpose of grasping the general image of the damage. Because the disaster by the earthquake occurred in wide areas, we carried out the first survey for multiple times, but cannot grasp the whole aspect of the damage. In this chapter, results of these multiple survey were summarized as basic documents to devise a survey plan in afterward to consider about the damage cause.

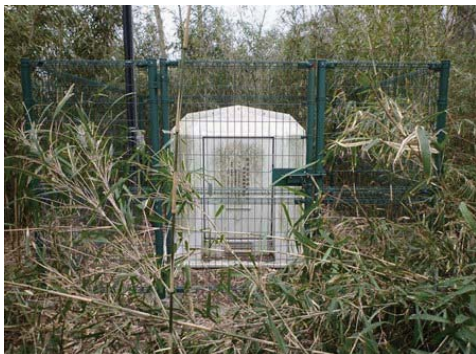
K-NET Kurihara Tsukidate (MYG004 : Instrumental seismic intensity 6.6) is set up on the hillock 3m higher (by eye measurement) than south of parking lot of Kurihara lyceum. There was a possibility of the amplification of earthquake motions (Photo 6.2-1). In Wakayanagi district, the ground was bad and sand boil due to liquefaction was observed (Photo 6.2-2). Damage to houses caused by ground transformation (Photo 6.2-3) and damage to houses with store were also observed (Photo 6.2-4).

Photo 6.2-1 K-NET KuriharaTsukidate

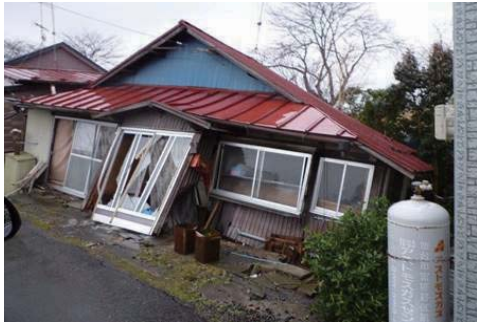
Photo 6.2-3 Damage of houses caused by ground transformation

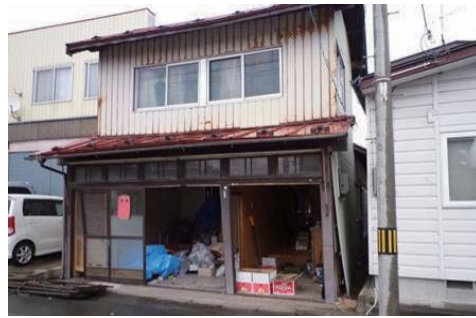
Photo 6.2-4 Damage of houses with store

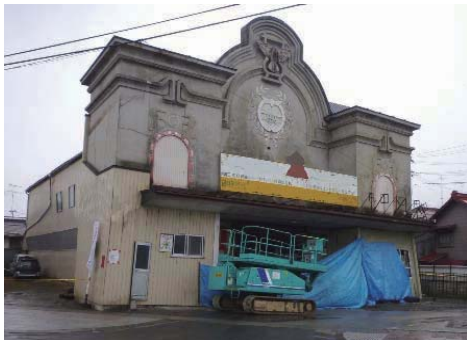
A large residual deformation was observed in the longitudinal direction in the large-scale wood building used as a movie theatre then renovated to a factory (Photos 6.2-5, 6.2-6)

Photo 6.2-5 Large-scale wood building renovated to a factory

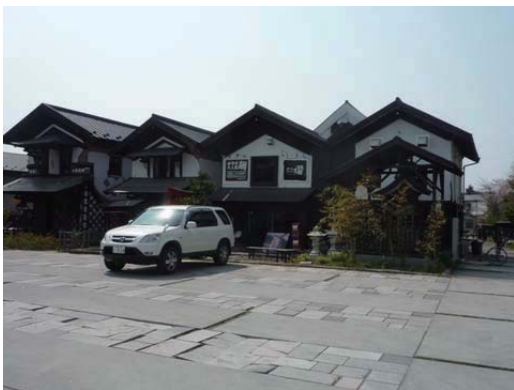
For example, warehouse with the mud walls renovated as store or gallery (Photo 6.2-11) was damaged heavily or slightly. There was the one whose roof system with roof tiles collapsed and fell down, as shown in Photo 6.2-12. In the area of these warehouses, there was a Japanese traditional post and beam construction house with large deformation (Photo 6.2-13) which was renovated as a store. On the opposite side of this house, there was the house with store (Photo 6.2-14) with story shear deformation whose exterior mortar came off and wood lath under the mortar near the opening of the ventilation fan was deteriorated and attacked by termites, as shown in Photo 6.2-15. Such damage was confirmed in the other buildings. Most of these damage occurred along a small river, except for a few case, and it was considered that the soft ground near the river might amplify the earthquake ground motion.

Photo 6.2-11 Warehouse with mud walls damaged heavily or slightly

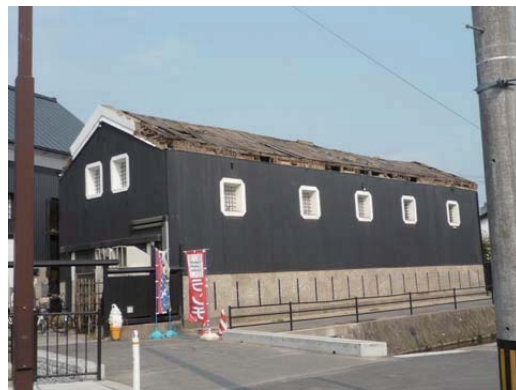
Photo 6.2-12 Warehouse with mud walls whose roof system with roof tiles fell down

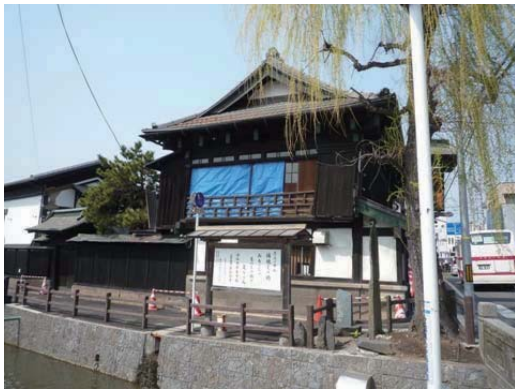
Photo 6.2-13 Damaged Japanese traditional house with large story deformation

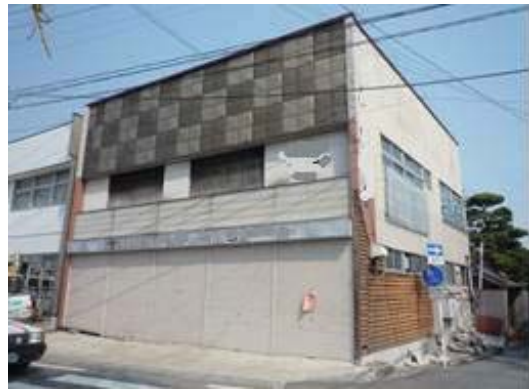
Photo 6.2-14 House with store with large story deformation

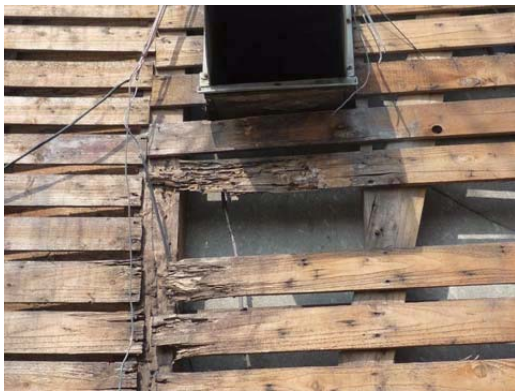
Photo 6.2-15 Deterioration in building of Photo 6.2-14

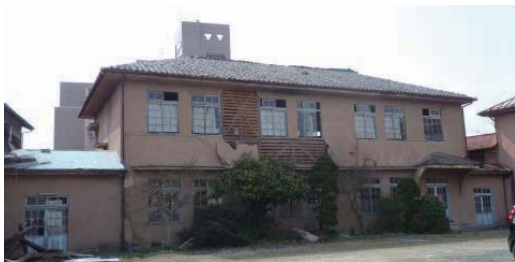
Photo 6.2-17 School building suffering damage on roof tiles and exterior walls

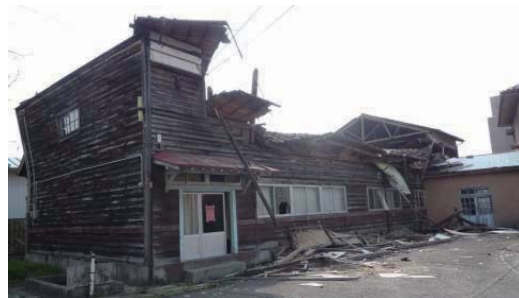
Photo 6.2-18 School building whose 2nd story collapsed

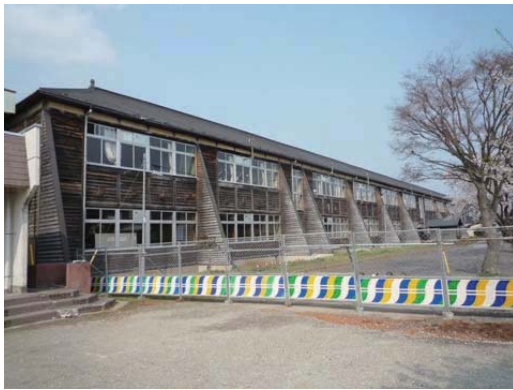
Photo 6.2-19 Seemingly slightly damaged School building

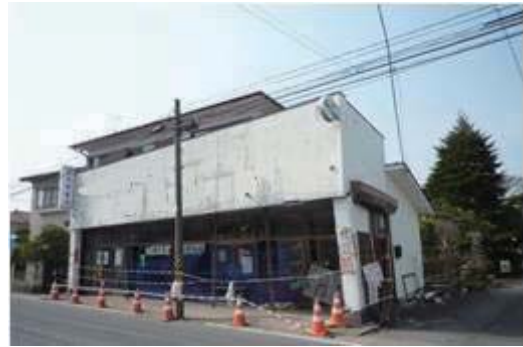
Photo 6.2-20 House with store with large story deformation

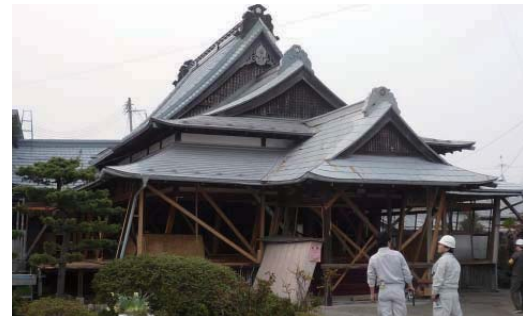
In the northwest of JR Freight Company Furukawa Station, a collapsed steel frame building, an RC structure apartment house with rocking drift caused by the land deformation, and a temple building (Photo 6.2-22) with large story deformation were observed.

Photo 6.2-22 Heavily damaged temple building

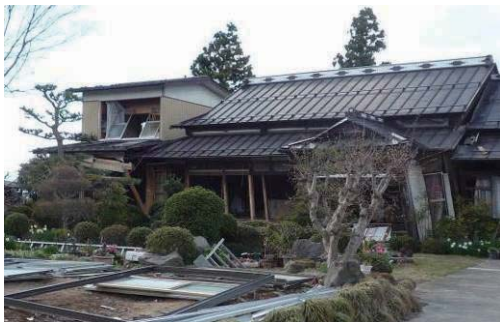
In Hirabari of Kogota area, there were a lot of wood houses which tilted largely in the east-west direction along the Eaigawa river (Photo 6.2-23). Photo 6.2-24 shows the wood house which leans to the fence. Most of the tombstones in this area fell toward in the east-west direction (Photo 6.2-25). Photo 6.2-26 shows the tilted wood house of

Photo 6.2-23 Largely tilted house

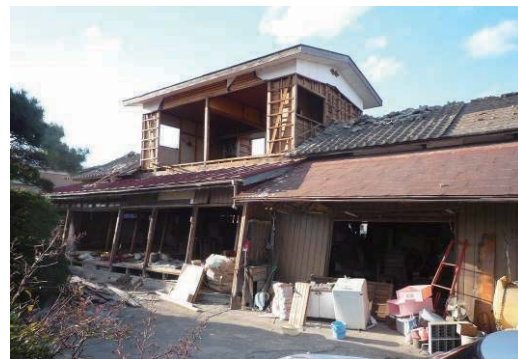
which two-story might have been extended. In the southern side of Eaigawa river, there were log house without damage (Photo 6.2-27), wood house which tilted largely at first story (Photo 6.2-28) and tilted shrine building (Photo 6.2-29).

Photo 6.2-28 Largely tilted wood house

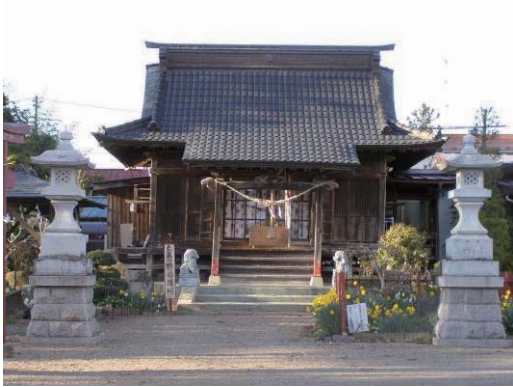
Photo 6.2-29 Damaged shrine

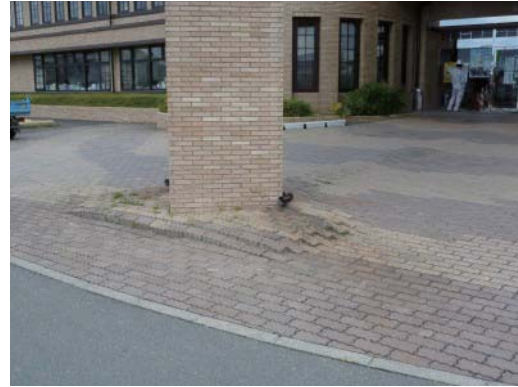
In Nango area, ground deformation was observed in the branch town office (Photo 6.2-30), but there were few damaged houses. Photo 6.2-31 shows the tilted wood house in Nango area. The structures in this area were damaged in a certain level during the 2003 northern Miyagi prefecture earthquake. There is a possibility that damaged buildings were retrofitted or rebuilt after the 2003 earthquake, because structures in this area seemed to be new.

Photo 6.2-30 Ground deformation in Nango branch town office

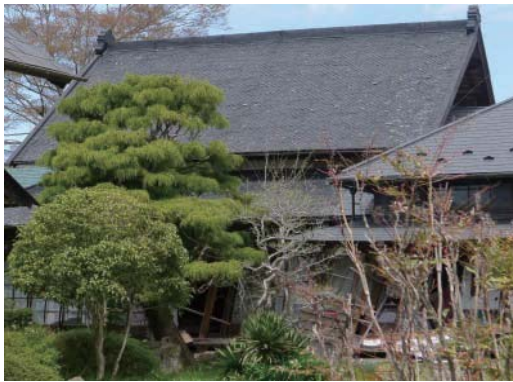
Photo 6.2-31 Heavily damaged house

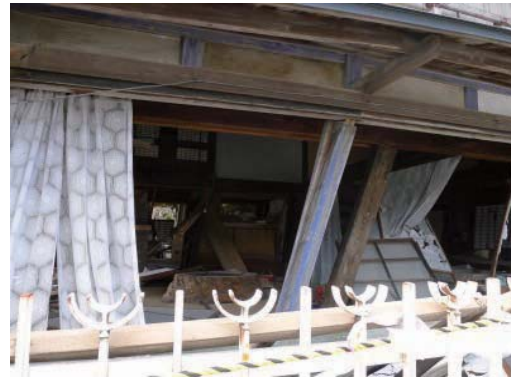
Photo 6.2-32 Inside of the house in Photo 6.2-31

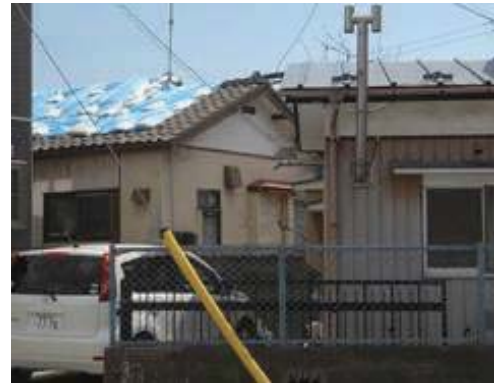
Hiyorigaoka and Izumi-cho in Ishinomaki city are located on a hill (max. Altitude, 56.4m) at the western side of Kyu-kitakami river, almost all of the buildings are residence without public facilities (Photo 6.2-33). There were not heavily damaged wood houses and a few wood houses of which roof tile damaged (Photo 6.2-34).

Photo 6.2-34 Damaged roof tile in Hiyorigaoka

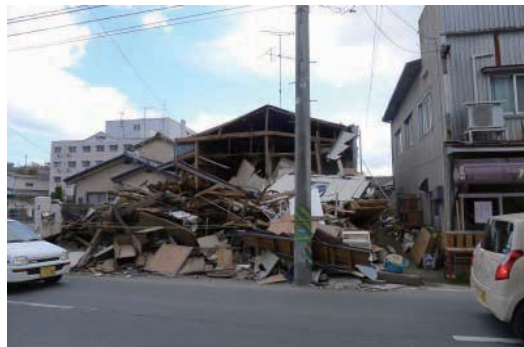
On the both sides of the street, there were collapsed wood house by earthquake (Photo 6.2-35) and tilted wood house with store (Photo 6.2-36). It was estimated that the wood houses with store which have less seismic elements at the first story were heavily damaged.

Photo 6.2-35 Collapsed wood house

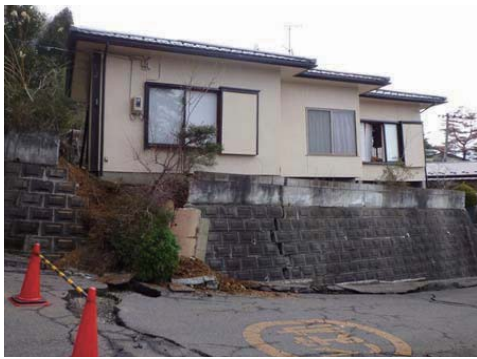
Photo 6.2-37 Damage of retaining wall and houses (Oritate, Aoba ward)

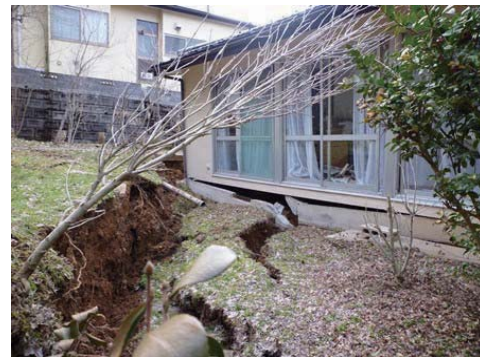
Photo 6.2-38 Damage of house in Photo 6.2-37

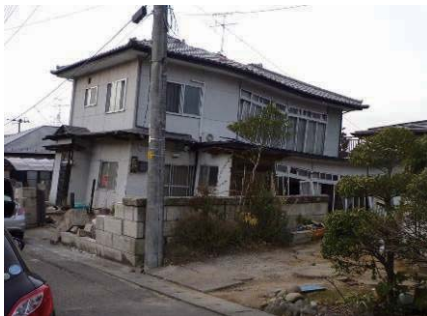
Photo 6.2-39 Damage of house caused by the ground transformation (Oritate)

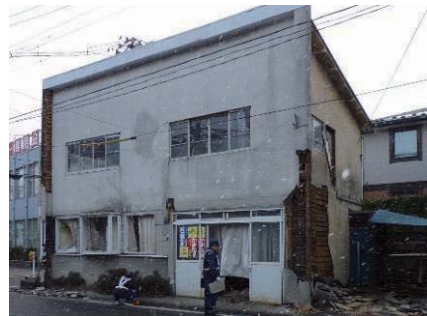
Photo 6.2-40 Drop off the mortar wall (Komatsujima)

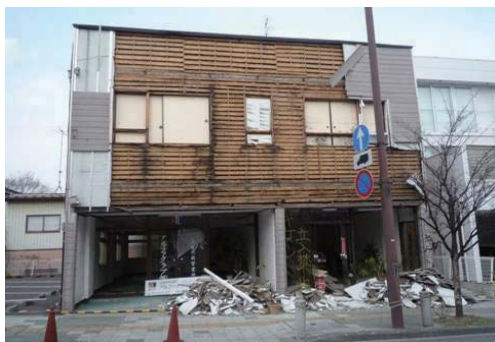
A lot of damaged wood houses were observed around the collapsed RC structure building. Examples are as follows: the failed exterior mortar wall of the 2nd floor in a house with store (Photo 6.2-44), deterioration and damage by *Reticulitermes* on a part of structural member and wood lath of exterior mortar wall (Photo 6.2-45), a wood house whose stair hall was removed and collapsed (Photo 6.2-46), and so on.

Photo 6.2-44 Fallen mortar of wall (Wood house with store)

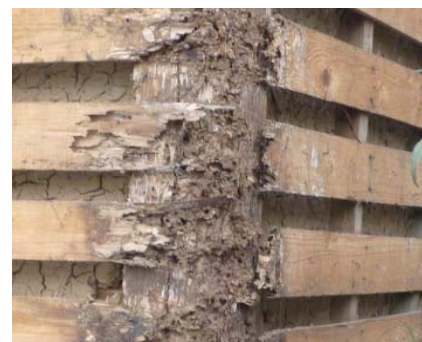
Photo 6.2-45 Deterioration and damage due to termite on column and wood lath of exterior mortar

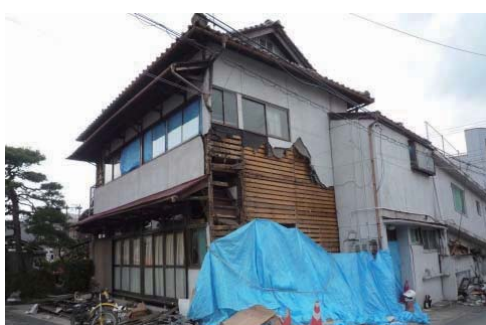
Photo 6.2-46 Collapsed stair hall

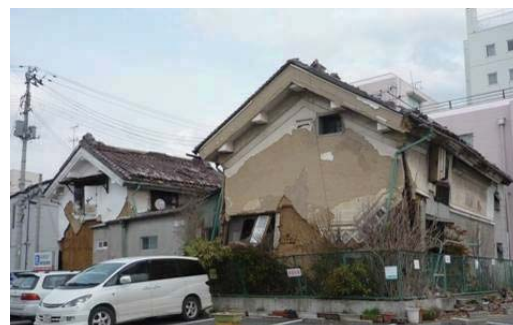
The wood warehouses with mud wall were heavily damaged near the hotel with the window glass broken. For example, the warehouses which deformed much (Photo 6.2-47) and whose roof system collapsed (Photo 6.2-48) were observed. A few wood houses with roof tiles damaged (*e.g.* Photo 6.2-49) were found. On the other hand, roof tiles of temple gate (called as “*Sanmon*”) were damaged, while the main hall of the

Photo 6.2-47 Failed warehouse with mud wall

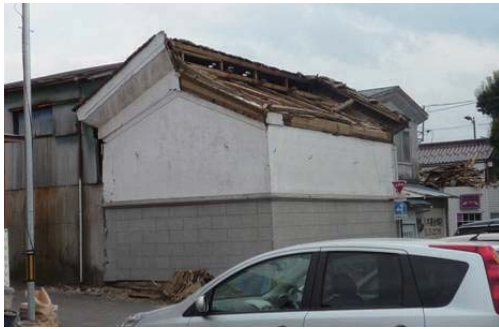
Photo 6.2-48 Fallen roof of warehouse with mud wall

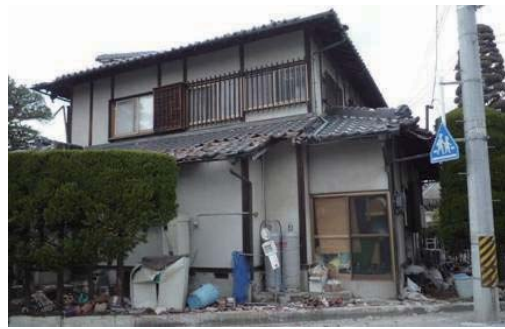
Photo 6.2-49 Damage of roof tile

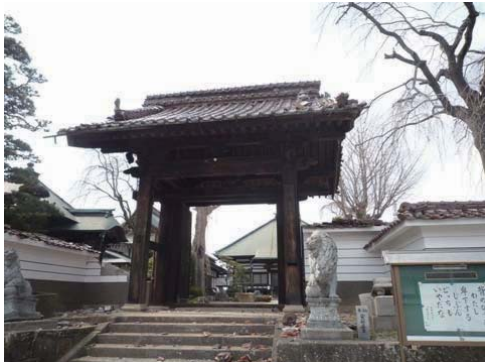
temple was not so damaged (Photo 6.2-50 and 51). The sand eruptions caused by the soil liquefaction and the damage on the roof tiles were seen here and there in Minami-machi, Sukagawa city. In addition, on the web site of the city, the collapsed house was reported (Photo 6.2-52, From the city website).

Photo 6.2-50 Minor damage of temple gate

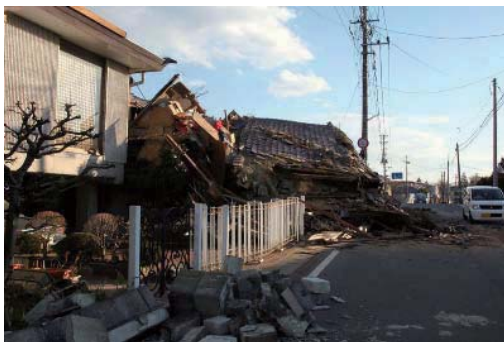
Photo 6.2-52 Collapsed wood house at Minami-machi (From Sukagawa city website)

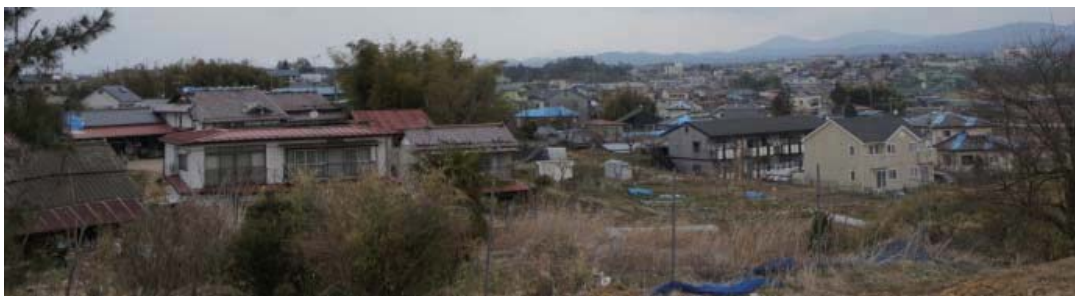
Another collapsed building with uncertain structural type was found (Photo 6.2-53). According to the damage overview seen from the east of Minami-machi (Photo 6.2-54), it was observed that the wood houses with roof covered temporarily with blue vinyl sheet which was guessed to be damaged to roof tiles were relatively many.

Photo 6.2-54 Damage overview from the east of Minami-machi (Many roofs covered with blue vinyl sheet)

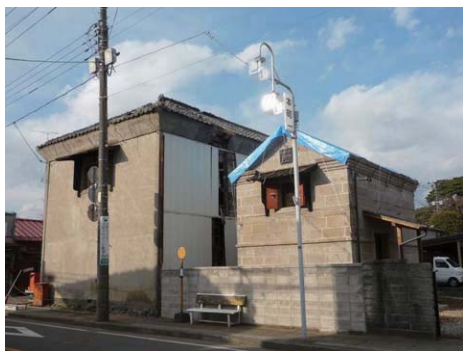
The stone-built warehouse was heavily damaged near the town office (Photo 6.2-55). The exterior stonewall of the former post office was failed (Photo 6.2-56).

Photo 6.2-55 Damage of stone-built warehouses

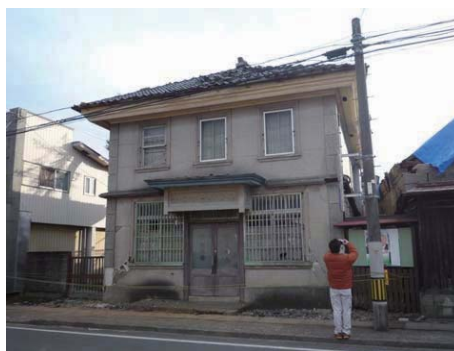
Photo 6.2-56 Damage of an old post office

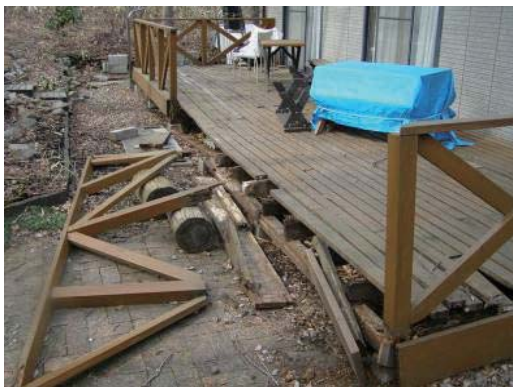
Toyohara-Otsu area is in the north of Nasu town, and cottages are built along the path on slightly elevated hills. The movement and collapse of the wood deck (Photo 6.2-57) and collapse of the stone exterior were often observed. Several damages on wood houses caused by the slope land or the embankment were observed. The damage on the wood house due to large ground deformation caused by the earthquake motion was also found (Photo 6.2-58). It was confirmed that the metal fasteners were installed in the column end joint and the brace end joint of this house. (Photo 6.2-59). Besides the story drift, crack of concrete foundation (Photo 6.2-60), crack and loss of the exterior siding board, broken window glass, and failed ceiling of eaves (Photo 6.2-61) were observed.

Photo 6.2-57 Damage of wood deck in Toyohara-Otsu, Nasu town

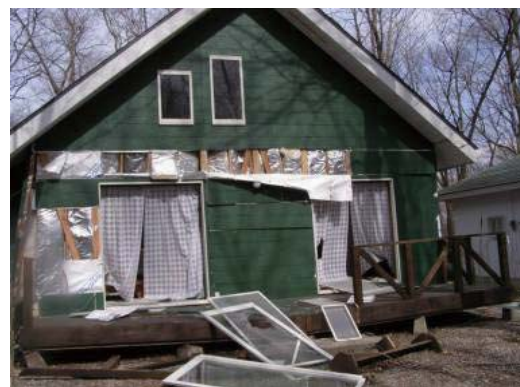
Photo 6.2-58 Heavily damaged wood house

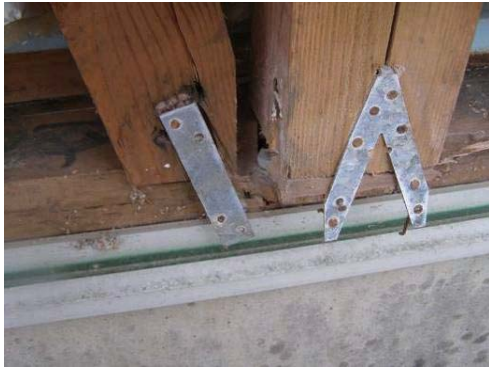
Photo 6.2-59 Metal fastener at the end of column and brace

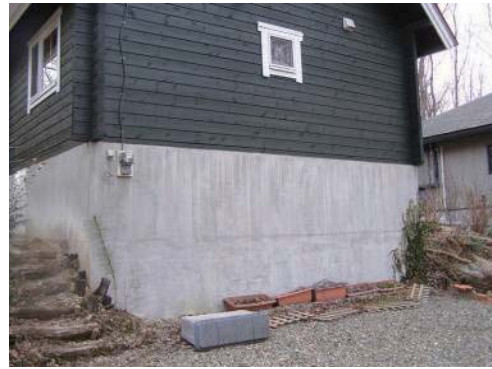
Photo 6.2-60 Crack of foundation

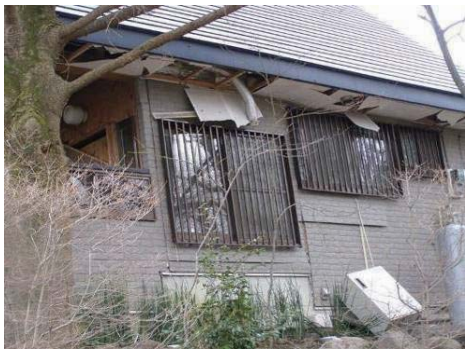
Photo 6.2-61 Failed ceiling of eave

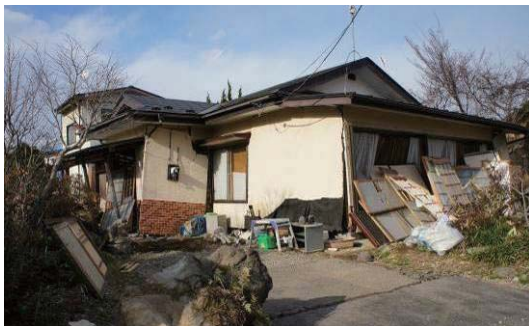
In Nishi-Ohkubo area, several wood houses whose exterior mortar wall in the 1st floor was almost failed were found (Photo 6.2-62). And, the wood house with large story drift (Photo 6.2-63) and the other one damaged due to deformation of the residential land (Photo 6.2-64) were found.

Photo 6.2-63 Wood house with large story drift

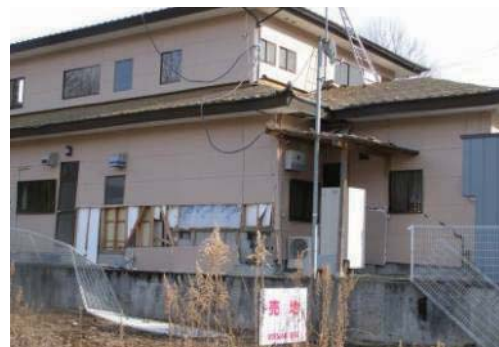
Photo 6.2-64 Damaged house due to deformation of residential land

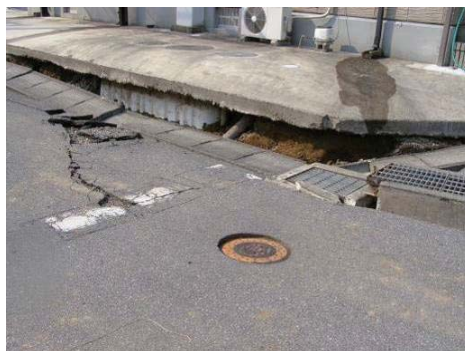
In Lobin-city (Photo 6.2-65), cracks of fence and retaining wall, caving of road bed, ups and downs of the residential land (Photo 6.2-66) and cracks of the foundation concrete (Photo 6.2-67) were often observed. In addition, damage on the roof tile, especially top of the roof, and collapsed concrete block fences were observed.

Photo 6.2-66 Ups and downs of residential land

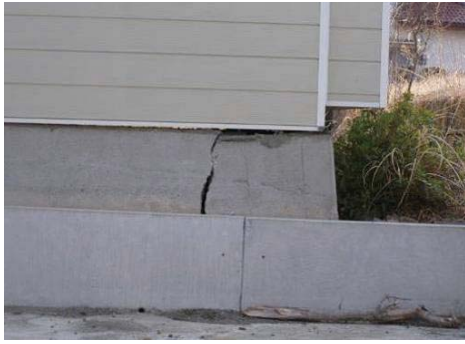
Photo 6.2-67 Crack of foundation

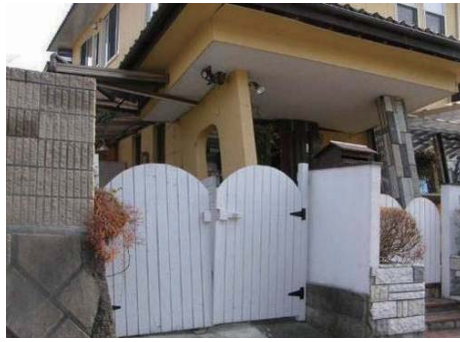
Narita-Happy-Highland located at the north of Lobin-city was a developed residential land. Most of the damage on buildings was due to the deformation of the residential land. A wood house with 1/10 radian shear deformation (Photo 6.2-68) was found.

Photo 6.2-68 Wood house with large shear deformation

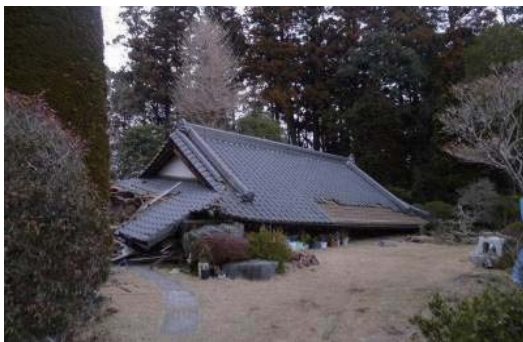
There were a lot of damaged fence made by the Ohyaishi stone. A collapsed farm type house was observed (Photo 6.2-69, 6.2-70). The mortar plastered wall finish of the wood house at the land filled paddy field fell down (Photo 6.2-71).

Photo 6.2-69 Collapsed wood house

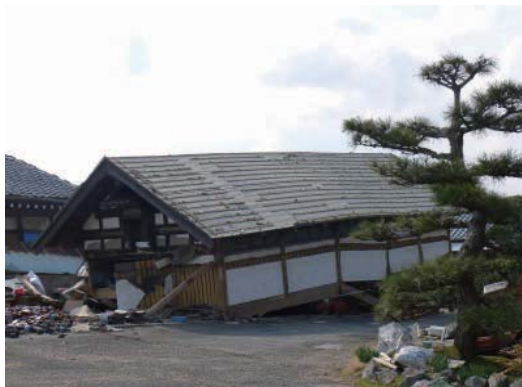
At Kadobe-shimogawara in Naka city, there were a lot of collapsed barns (Photo 6.2-72) and heavily damaged nagayamon gates (Photo 6.2-73). A damaged house with store was observed (Photo 6.2-74). A lot of collapsed barns were observed at Kadobe-akutsu.

Photo 6.2-72 Collapsed nagayamon gate (Kadobe)

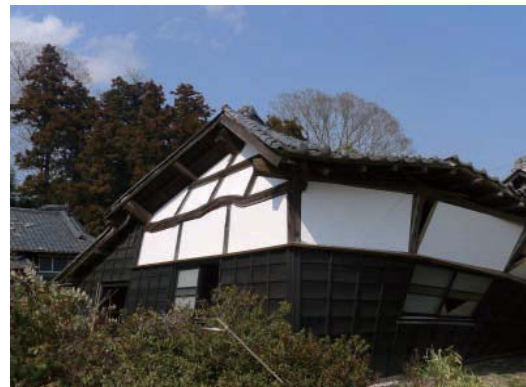
Photo 6.2-73 Tilted nagayamon gate (Kadobe)

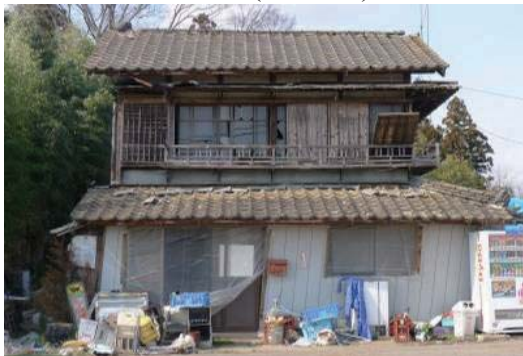
Photo 6.2-74 Damaged house with store (Kadobe)

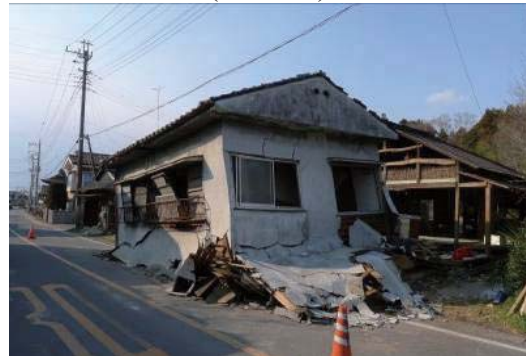
A two story wood house with mortar finish collapsed at the urban area of Urizura in Naka city (Photo 6.2-75).

Photo 6.2-75 Collapsed house (Urizura)

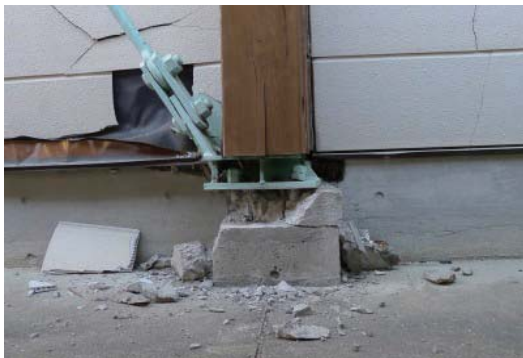
Photo 6.2-78 Breakage of the foundation concrete

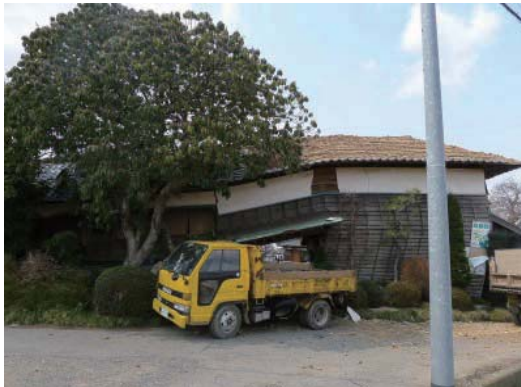
There was a heavily damaged Nagayamon gate at Yoshinuma-cho (Photo 6.2-81). The damaged barns were observed at Aoyagi-cho, Yanagawa-cho, Taya-cho (Photo 6.2-82).

Photo 6.2-81 Heavily damaged Nagayamon gate (Yoshinuma-cho)

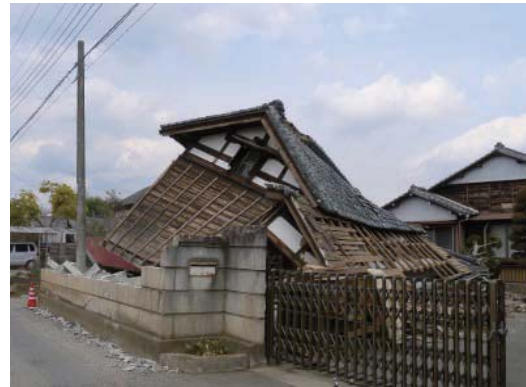
Photo 6.2-82 Damaged barn (Aoyagi-cho)

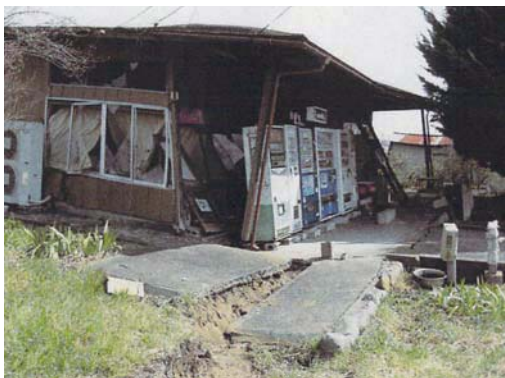
Photo 6.2-83 Damage of resting place (Joja-machi, offered by Joso city office)

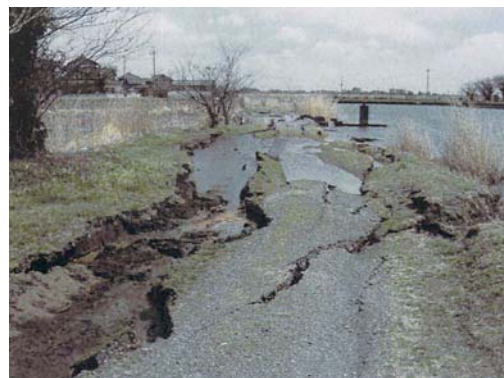
Photo 6.2-84 Damage of ground near the resting place (offered by Joso city office)
