9. Response of Seismically Isolated Buildings

9.1 Outline of Surveyed Buildings

9.2 Behavior of Seismically Isolated Buildings

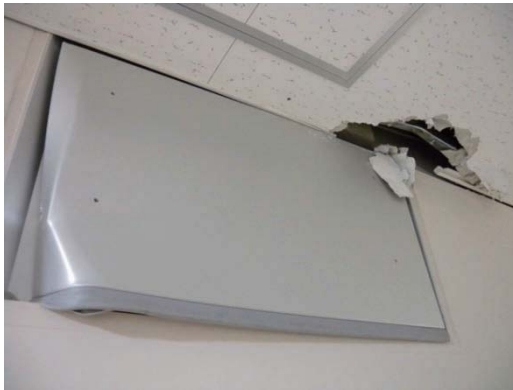
- According to the person in charge of the building, no furniture was turned over and no structural damage was observed.
- However, some damage was observed at the cover-panels of fire protection and the expansion joints near the boundary between isolated and non-isolated floors (Photo 9.2-2). It seems that parts of expansion joints were not well operated due to the large displacement of SI floor during the earthquake.
- The ground surrounding the building partially subsided around 10 cm.

(a) Damage to the panel

Photo 9.2-2 Damage near the boundary between isolated and non-isolated floors

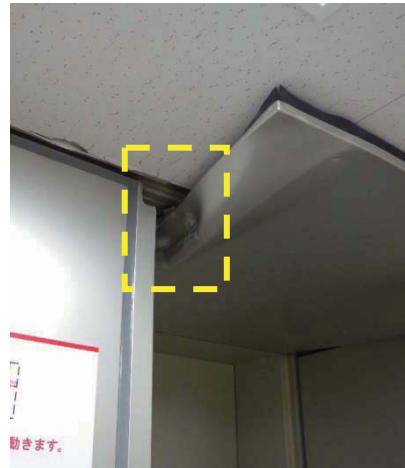
(b) Damage to the expansion joint

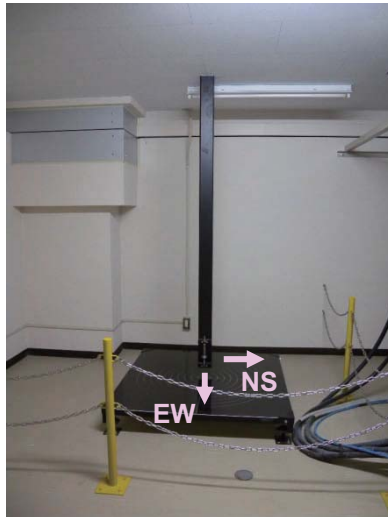
Photo 9.2-3 Scratch board installed on the SI floor

From the trace on the scratch board installed on the SI floor (Photo 9.2-3), the maximum displacement was estimated as around 18 cm at the mainshock on 11 March, 2011 and around 10 cm at an aftershock on 7 April, 2011 (Photo 9.2-4).

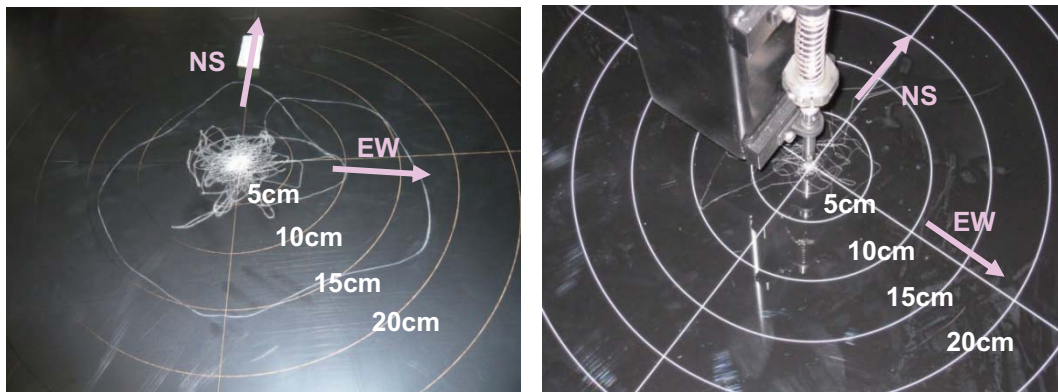
(a) Trace at the mainshock on 11 Mar. (b) Trace at an aftershock on 7 Apr.

Photo 9.2-4 Trace of displacement of SI floor during earthquake

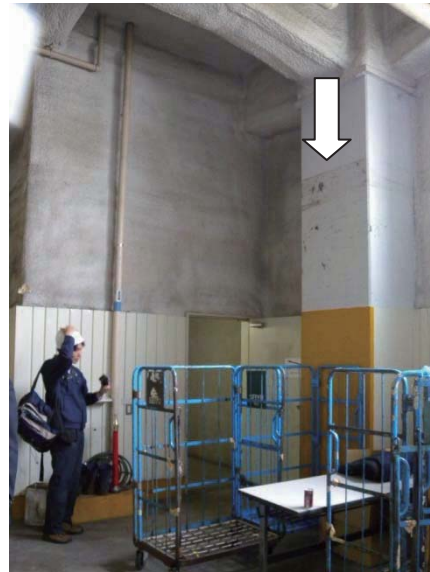
- b) Tsunami height was estimated around 4.0 m from the trace of water on the wall (Photo 9.2-7) and damage situation of surrounding buildings (Photo 9.2-8). There was no information about the direction and impact force of tsunami.

Photo 9.2-7 Trace of tsunami water

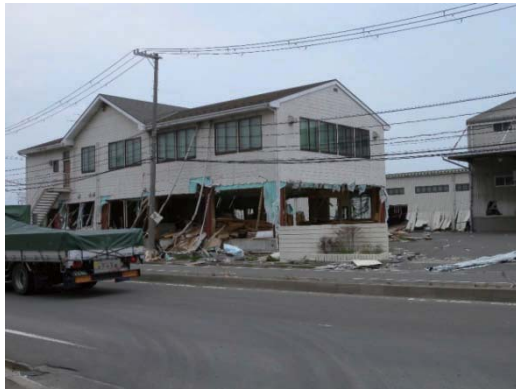
Photo 9.2-8 Tsunami damage to surrounding buildings

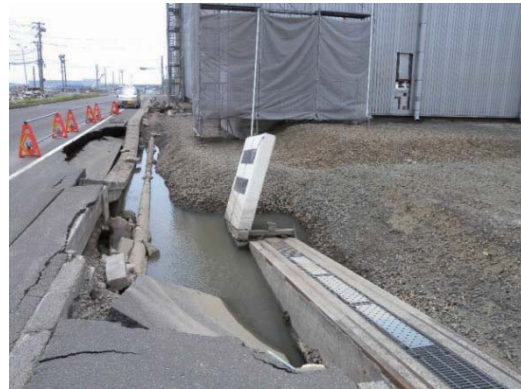
- c) The ground was excavated in northeast corner of the building around 1.0 m depth, probably because of the water flow from the building at the moment of tsunami (Photo 9.2-9).

Photo 9.2-9 Excavation of ground

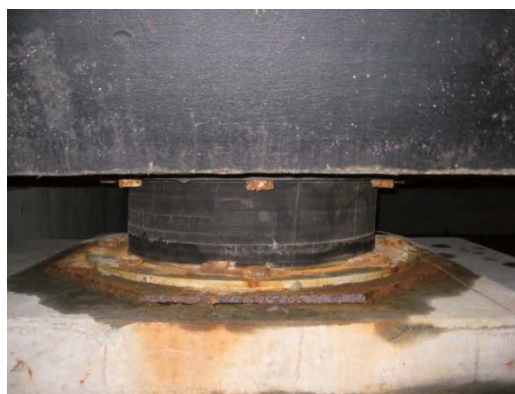
- d) From visual inspection, there was no harmful scratch or inflation of the rubber of HRB, however, severe rust was observed at the steel plates and bolts (Photo 9.2-10).

Photo 9.2-10 Rust of High-damping rubber bearing

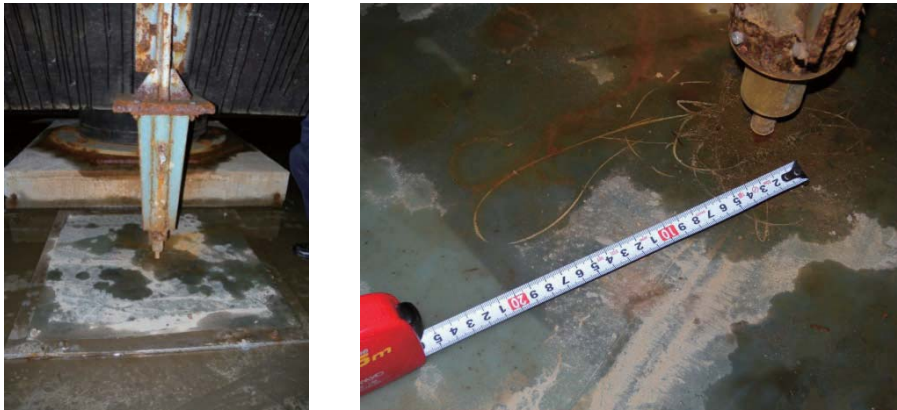
From the trace on the scratch board in the SI floor, the maximum displacement

was estimated as around 21 cm at the mainshock (Photo 9.2-11).

Photo 9.2-11 Trace of displacement of the SI floor on the scratch board

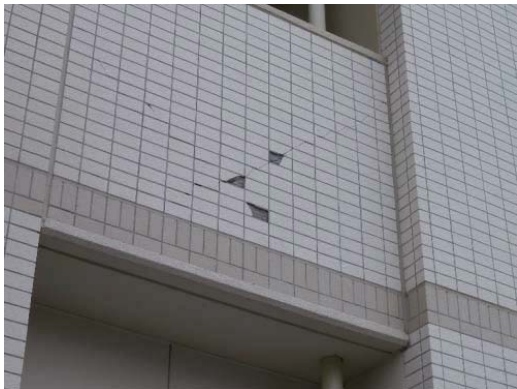
- a) According to the person in charge of the building, no furniture was turned over and no structural damage was observed inside of rooms. However, the damage to the expansion joint was observed.
- b) Drop of the ceramic tiles on outer wall (Photo 9.2-13) and shear crack on the wall in

Photo 9.2-13 Drop of ceramic tiles

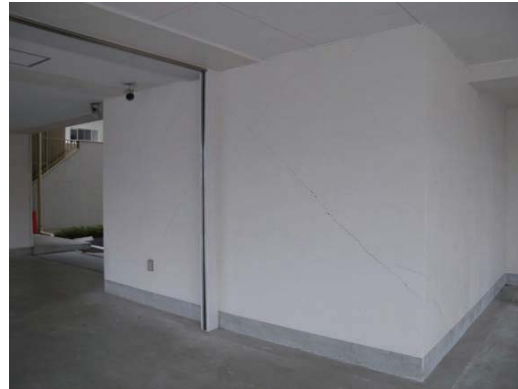
the first floor parking space (Photo 9.2-14) were observed. The subsidence of ground around 10 cm was observed around the building.

Photo 9.2-14 Shear crack on the wall

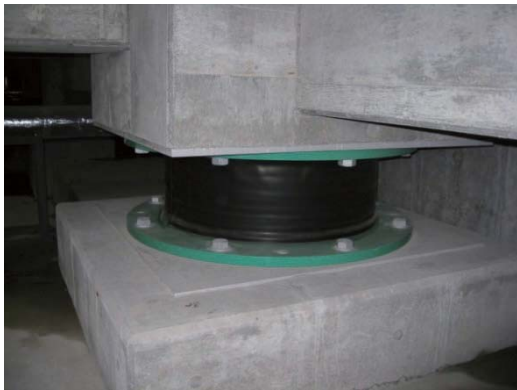
- c) No damage was found to RBs by visual inspection (Photo 9.2-15), however, paint of USDs was peeled off (Photo 9.2-16) and many cracks were found on LDs (Photo 9.2-17).

Photo 9.2-15 Natural rubber bearing

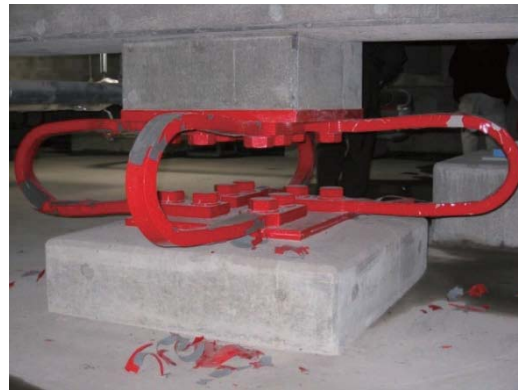
Photo 9.2-16 U-shaped steel damper

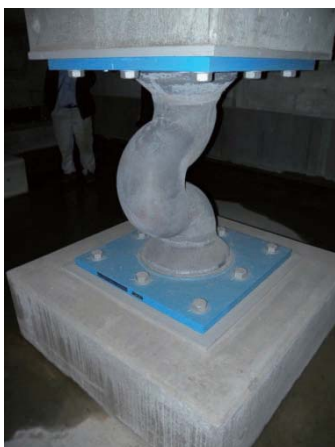
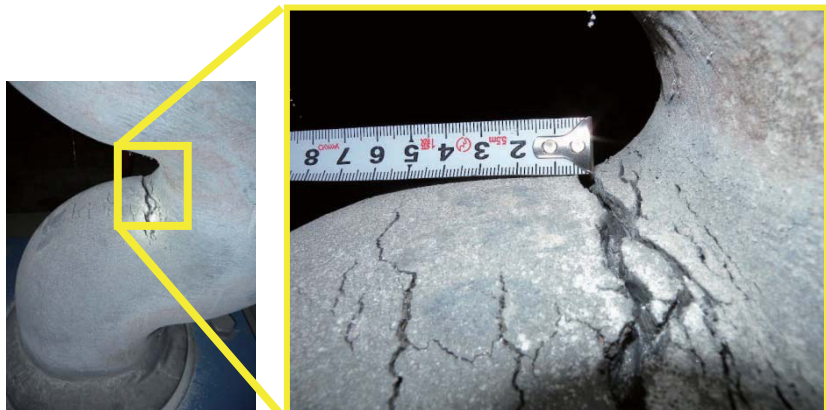
Photo 9.2-17 Lead damper and cracks on the surface

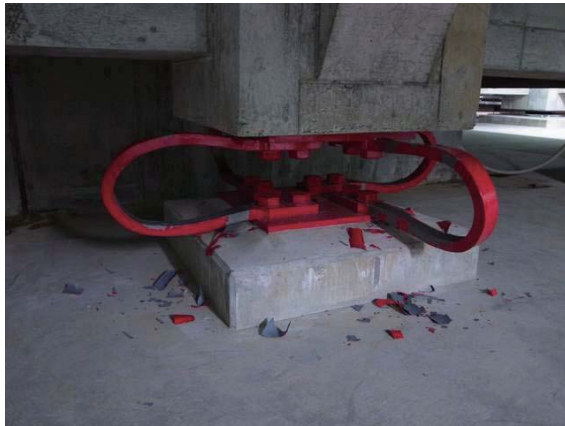
- According to the person in charge of the building, no furniture was turned over and no structural damage was observed.
- Because of the movement of the SI floor during the earthquake, the bolts of steel dampers became loose and the paint on the dampers was peeled off widely. Furthermore, a large amount of residual deformation of steel was remained (Photo 9.2-19).

(a) Peeling off of paint

Photo 9.2-19 Deformation of U-shaped steel damper

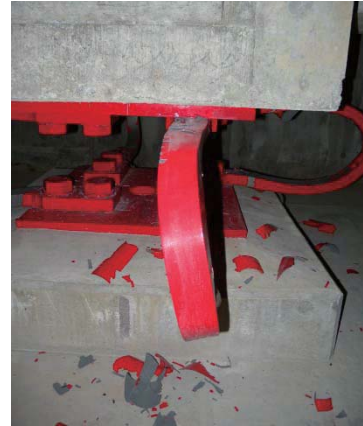
(2) Deformation of steel

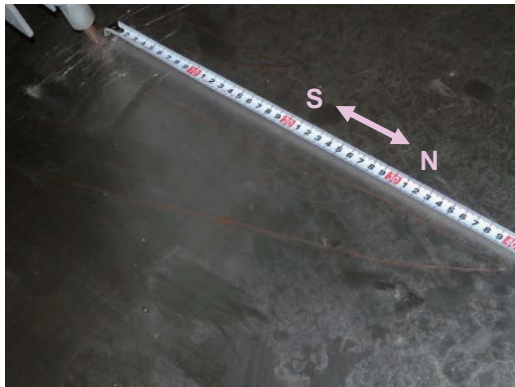
According to the scratch board in the SI floor, the maximum displacement was estimated as around 40 cm northward (Photo 9.2-20). The displacement was also confirmed from the trace of scratch found at the expansion joint outside of the building.

(a) Around 40 cm northward

Photo 9.2-20 Trace of displacement of the SI floor on the scratch board

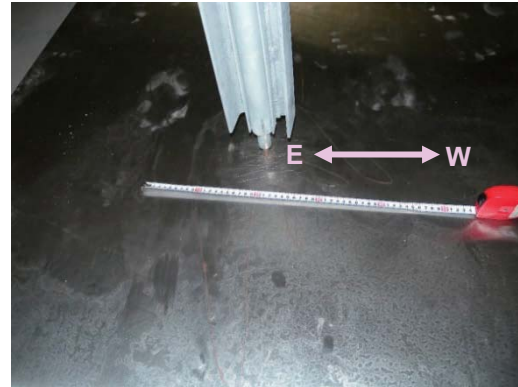
(b) Around 15 cm eastward
and 22 cm westward

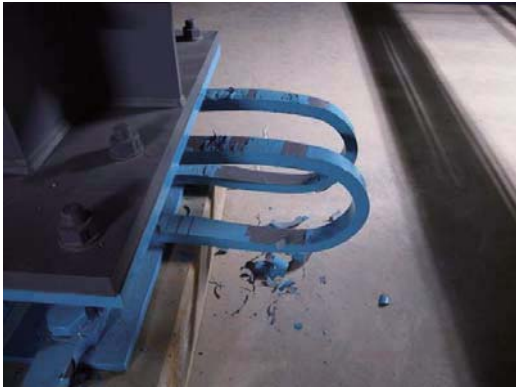
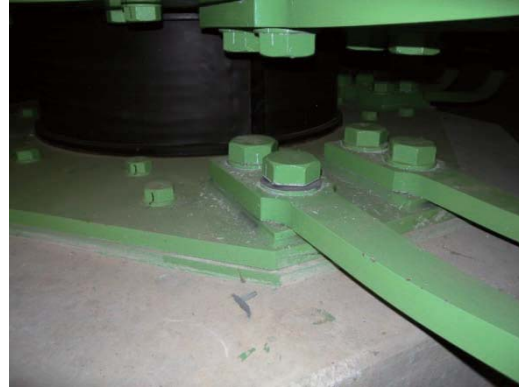
- a) According to the person in charge of the building, up-down shaking happened together with horizontal shaking during the earthquake. On the 6th floor, contents inside of the rooms such as refrigerators and shelves were moved or turned over, and the fire protection steel door moved to open and hit against the ceiling by vertical shaking causing the damage to the lamp covers. Above the 4th floor, PC monitors were turned over.
- b) In the penthouse, anti-vibration rubber of a power generator was moved and the bottom part of a water tank was broken.
- c) Because of the movement of the SI floor during the earthquake, the bolts of the steel dampers became loose and the paint on the dampers was peeled off (Photo 9.2-22).
- d) The ground around the building subsided around 20 cm.

Photo 9.2-22 Peeling off of paint and loose of the bolts of U-shaped steel dampers

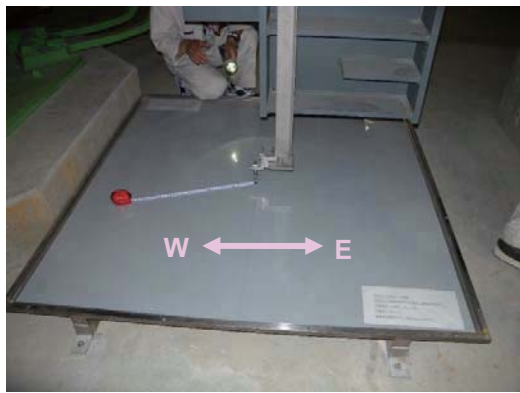
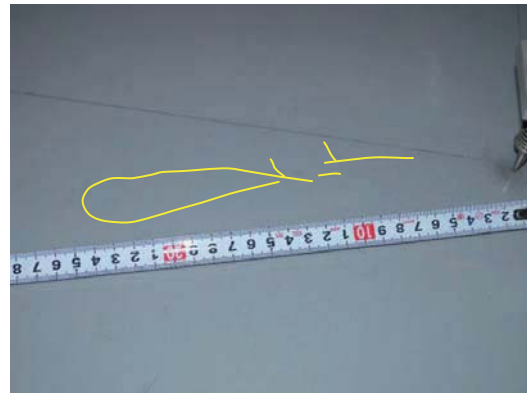
From the trace on the scratch board in the SI floor, the maximum displacement was estimated as around 25 cm westward (Photo 9.2-23). The displacement was also confirmed from the trace of displacement of the ESB (Photo 9.2-24).

Photo 9.2-23 Trace of displacement of the SI floor on the scratch board

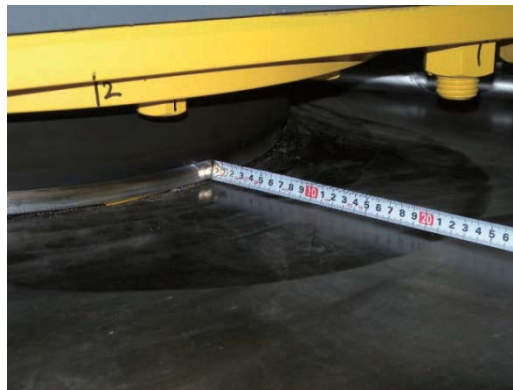
Photo 9.2-24 Trace of displacement of elastic sliding bearing
