Quick report of building damages in 2007 Peru Earthquake

August 24th, 2007

Taiki Saito, Building Research Institute

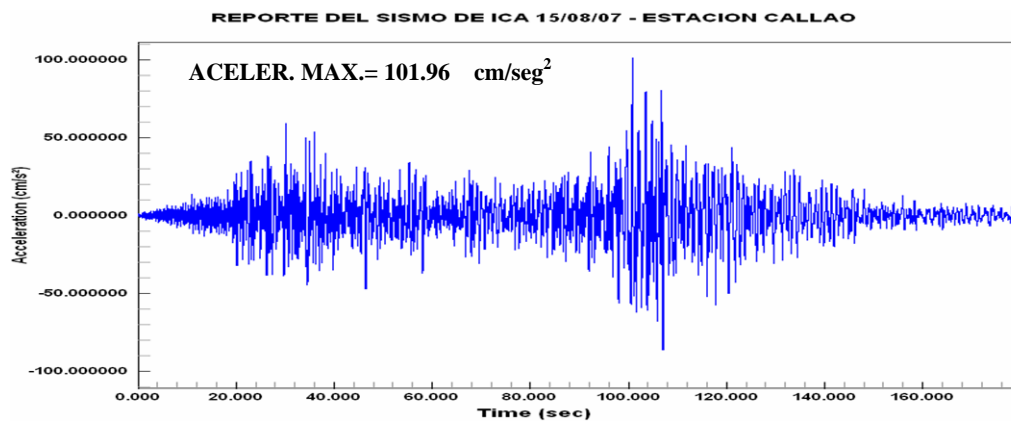
4 Strong motion seismograms were recorded in Lima. The earthquake seismograms in the city, Ica, close to the earthquake center also recorded by the seismometer installed by CISMID.

Figure 2: Strong earthquake motion observed in the city Lima (It shows double shocks)

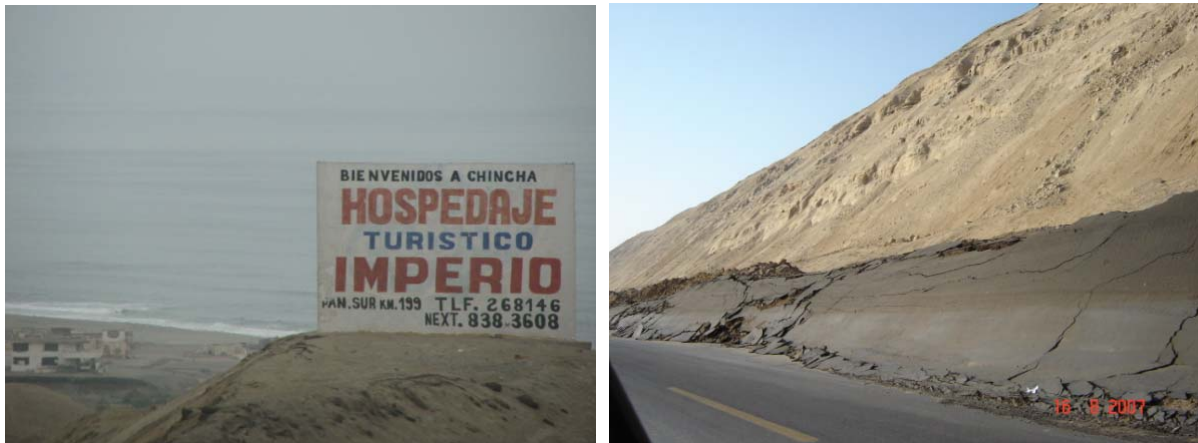
The damages of highway were found in many places caused by liquefaction after passing through Canete area. There were big waterholes along the coast made by the tsunami.

Photo 1: A part of high way was pushed up due to upheaval of east side of highway

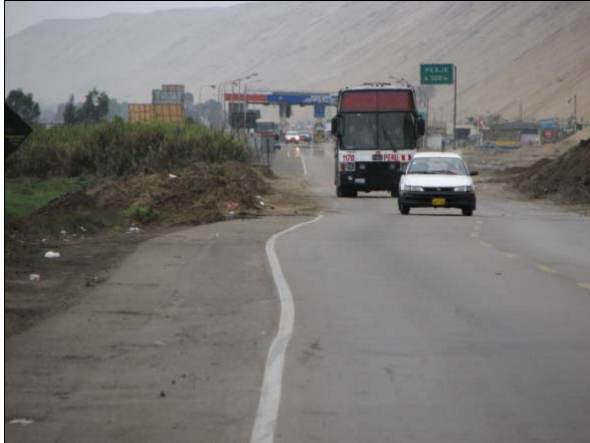
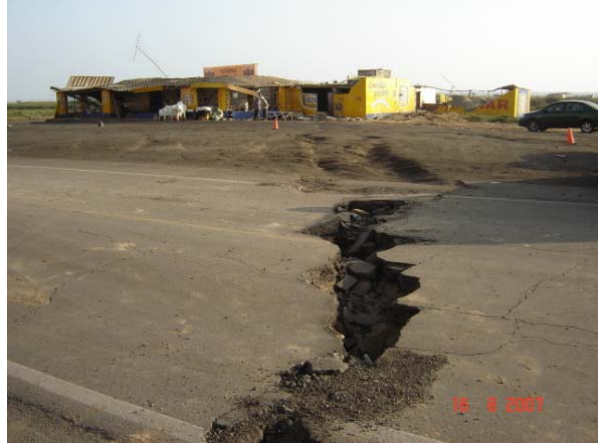
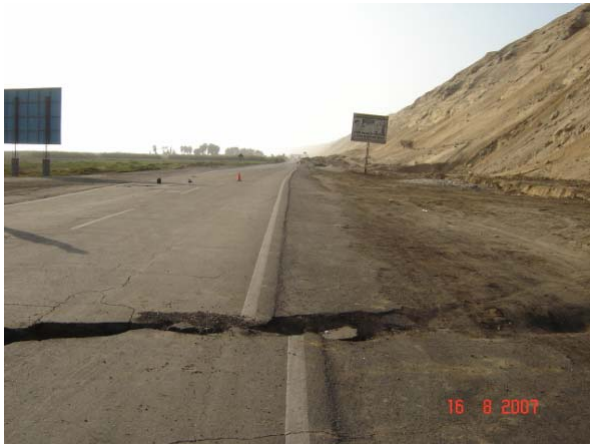
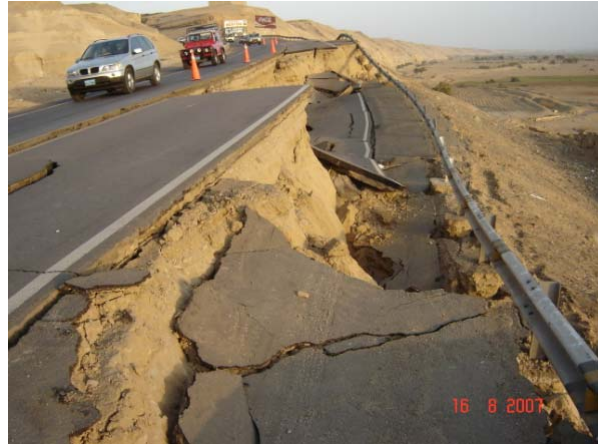
Photo 2: Cracks and subsidences of roads where traffics were restricted

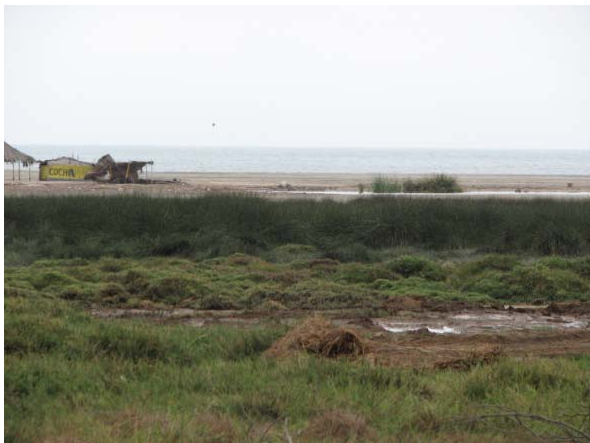
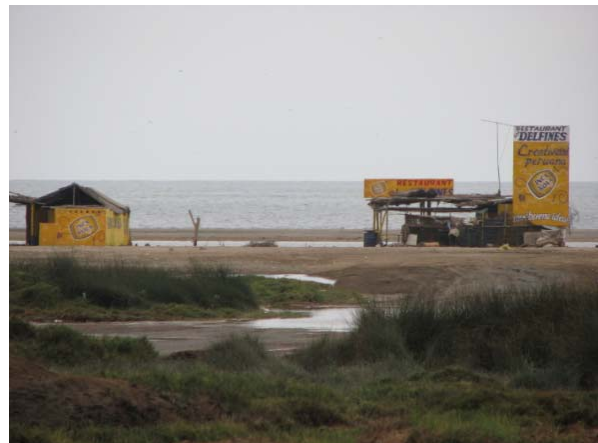
Photo 3: Waterholes on swampland along ocean-side by the Tsunami

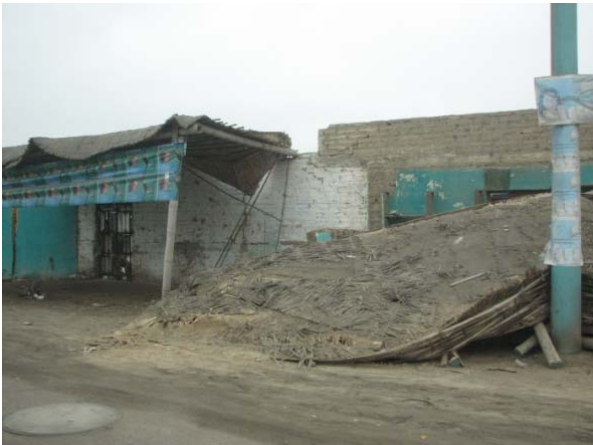
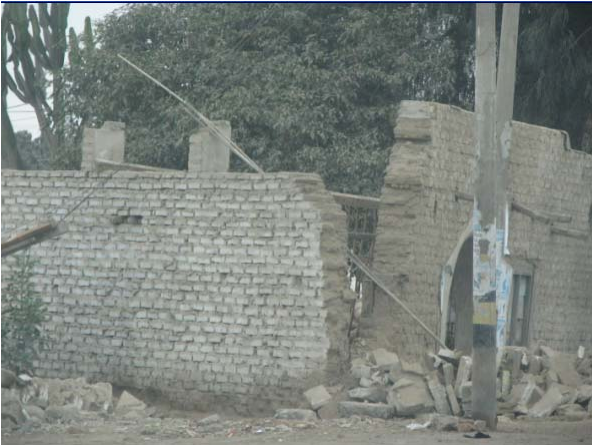
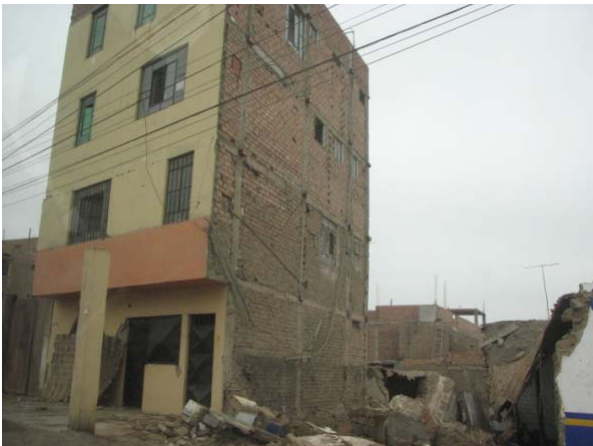
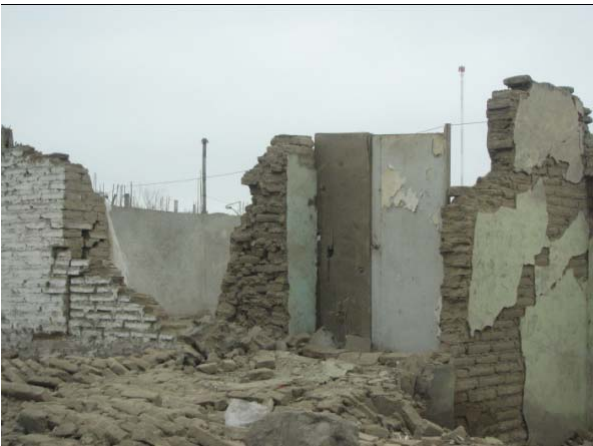
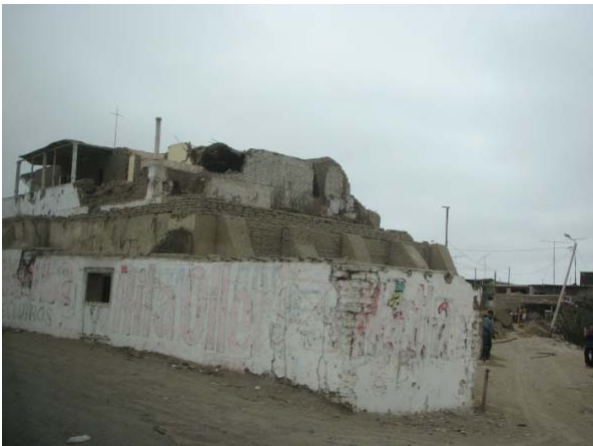
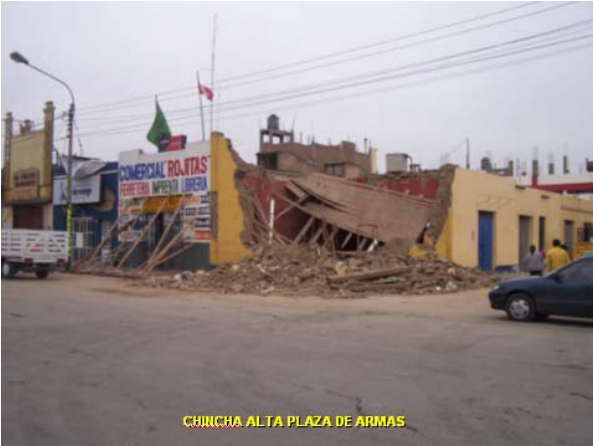
The damages in Canete were lower compared with those in Chincha and Pisco, even though Canete is located the closest to the epicenter of earthquake. Dr. Akio Abe (Tokyo Soil Research Co. LTD) explained that the reason why Canete had less damages is the ground condition in Canete is better than that in Chincha and Pisco. Buildings of adobe structure had serious damages in Chincha. Damages of confined masonry structure buildings are not so much in

general.

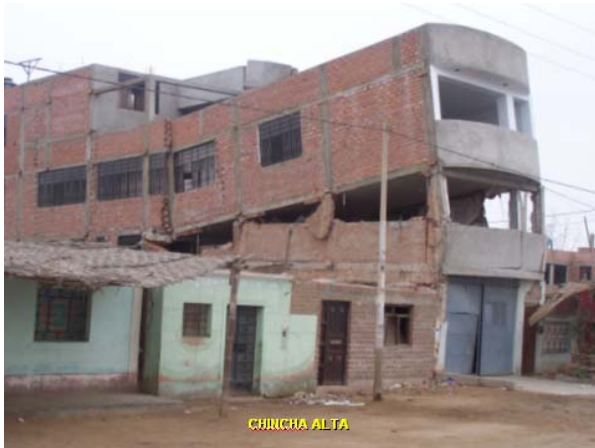
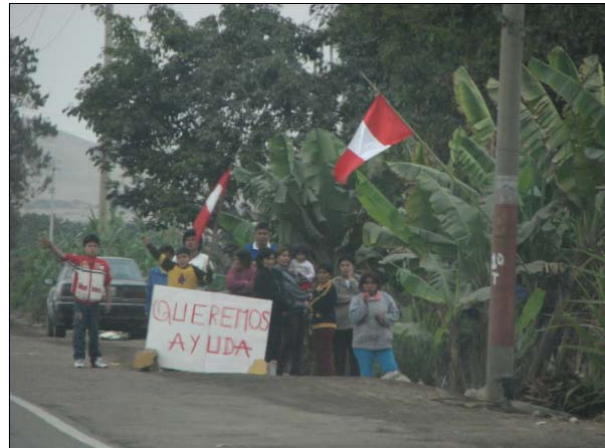
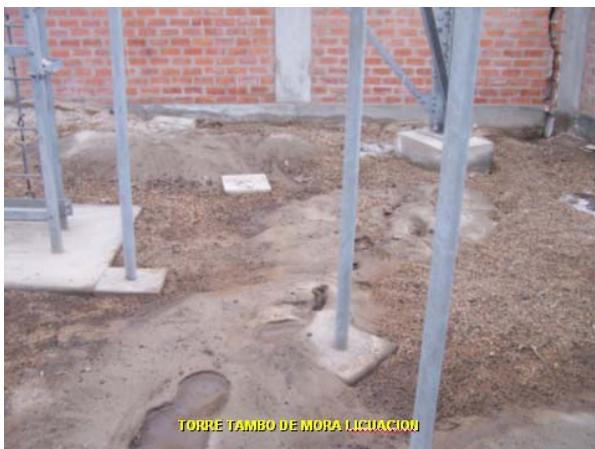
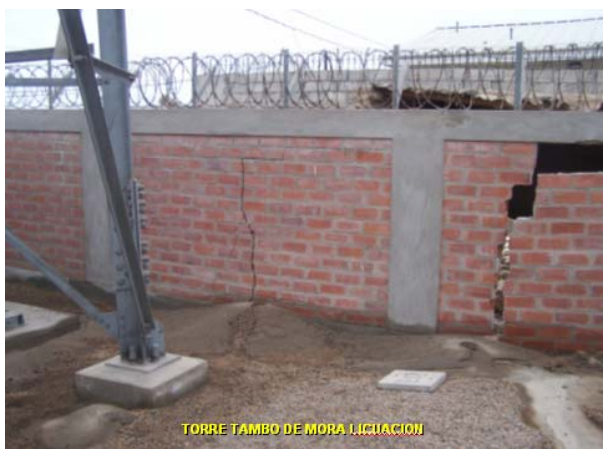
Photo 4: Damages due to liquefaction in Torre Tambo De Mora Licuaction. Many people crowded along the highway for water and food

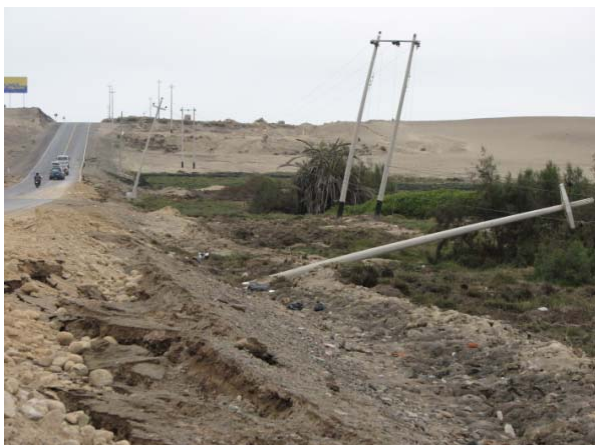
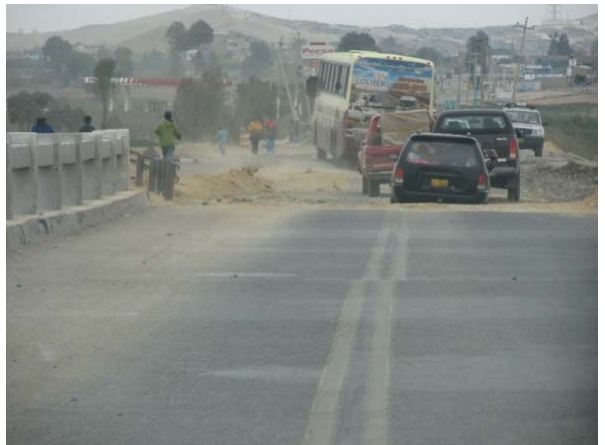
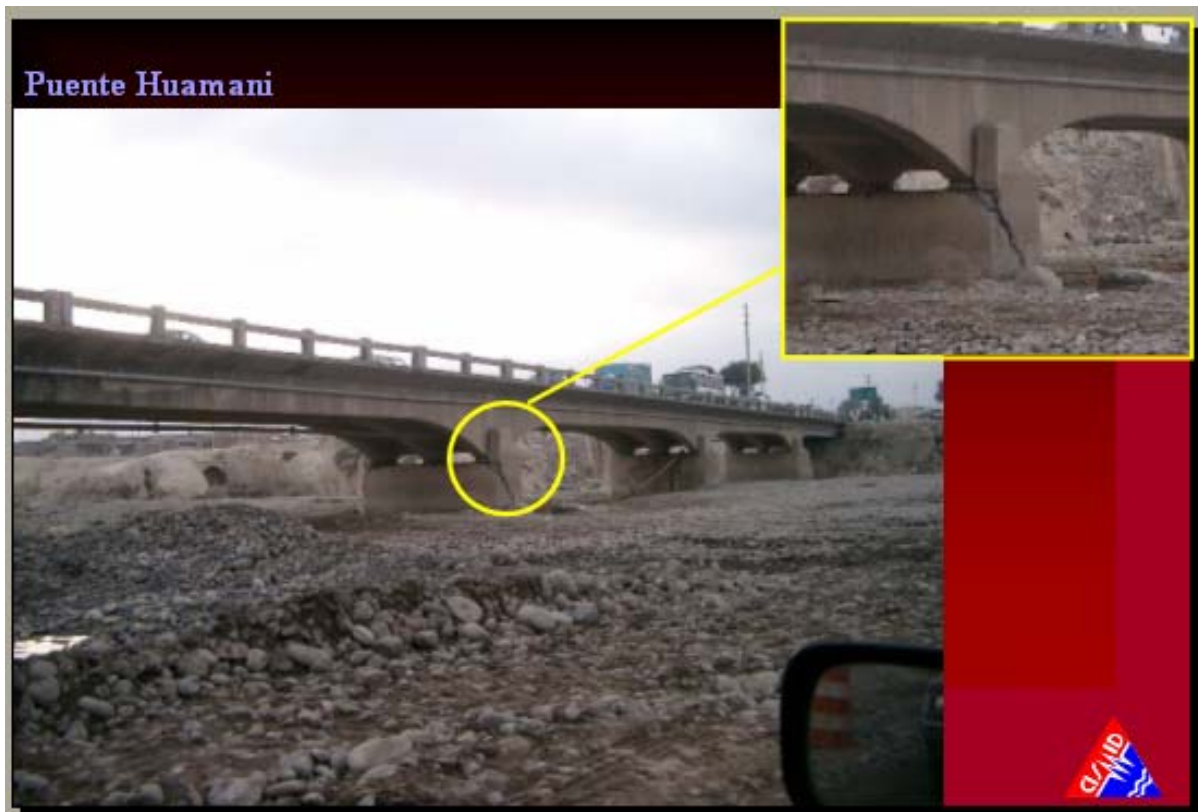
A bridge collapse blocked to go to Pisco right after the earthquake. Afterwards, a detour was made by dammed up the river. The bridge was used for a one way passage. There were swales around and the ground was not good.

Photo 5: Damaged bridge near Pisco. It was used for a one way passage

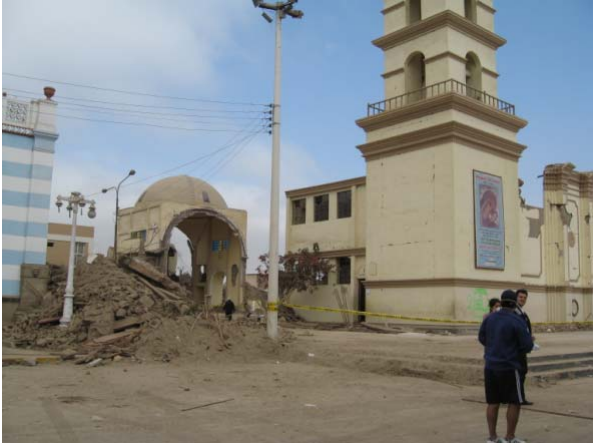
The central church in the town (CATEDRAL SAN CLEMENTE) was completely collapsed and 148 were found dead and two survived. It was built by adobe structure. Two towers, which were remained safe, had signs of repair works with flames of reinforced concrete. The rescue team of the government said, more than 10 people were left buried under rubbles in Hotel Embassy which was almost collapsed.

Photo 6: Damage of Church

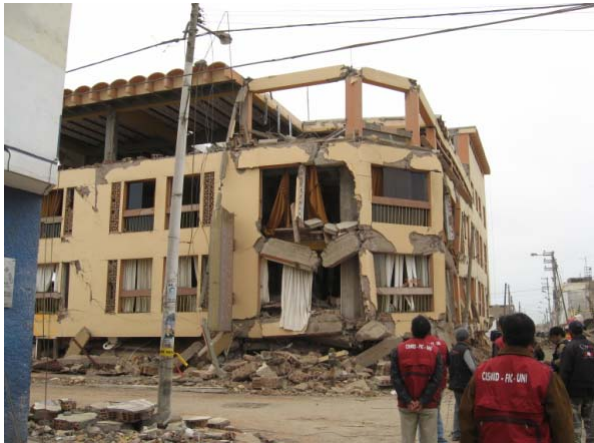
Photo 7: Damage of Hotel

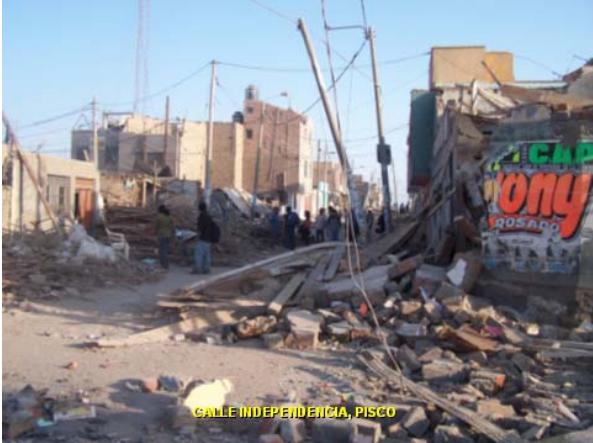
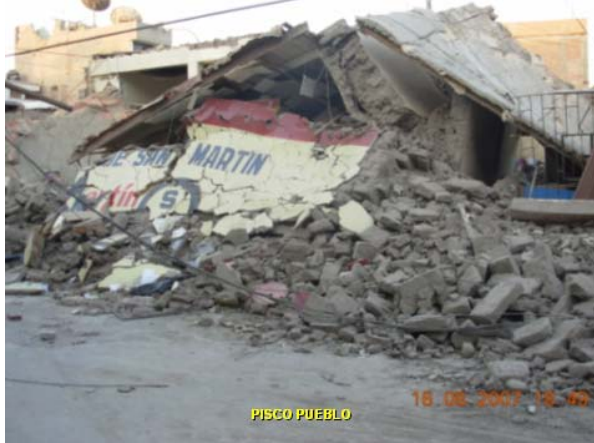
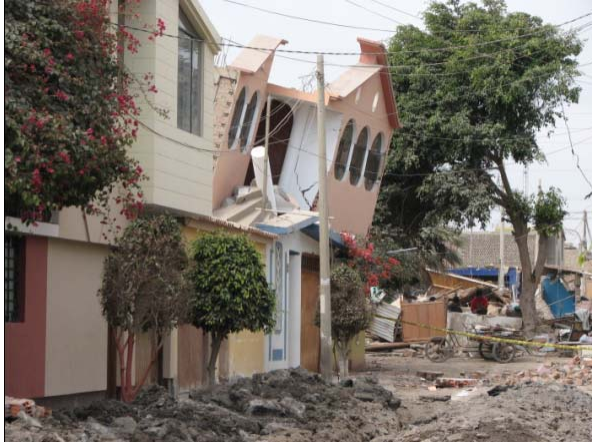
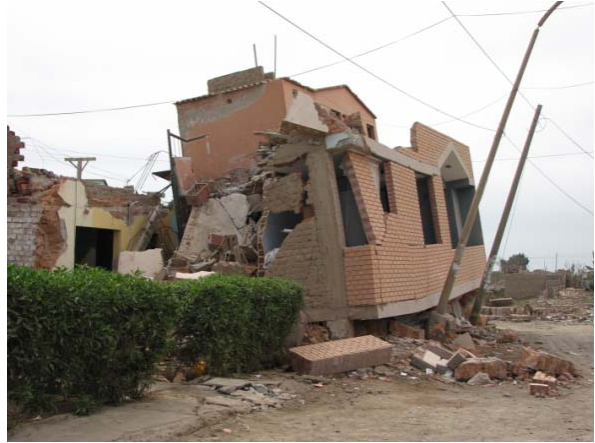
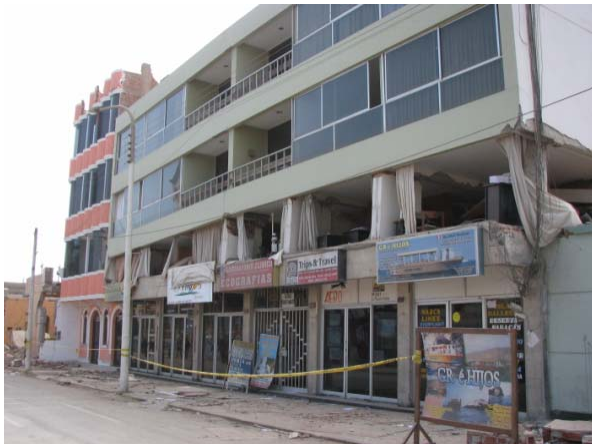
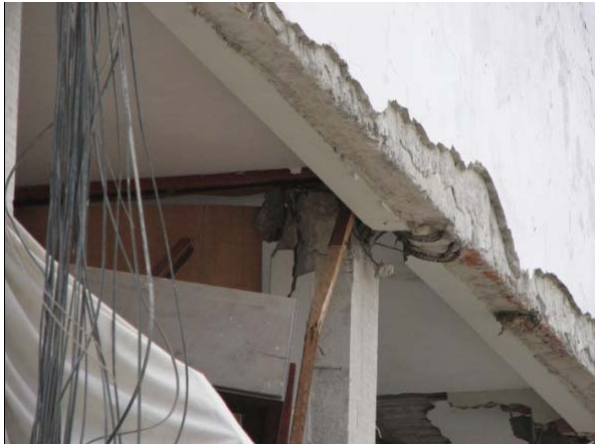
Most of low-rise buildings are adobe structures and mid-rise ones are confined masonry structures. Most buildings in a street were completely collapsed, but some adobe structure buildings were remained. Most of damage in confined masonry buildings was the collapse at parts of concrete casting joints in the upper part of columns and joints between columns and girders. Hospitals built by confined masonry structure were heavily damaged. There was no damage to buildings which were designed by the new building standards.

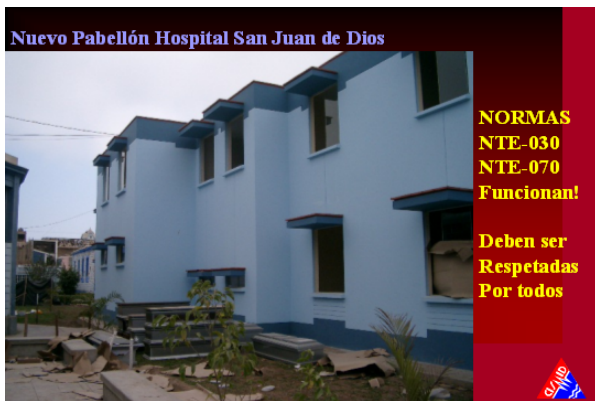
Hospital C (new building with no damage)
