PROCEEDINGS
of
INTERNATIONAL VIDEO WORKSHOP 2009
on
SAFER HOUSING FOCUSING ON CONFINED
MASONRY STRUCTURES

枠組み組積造の耐震性向上に関する国際ビデオワークショップ報告書
＜振動台実験結果、壁体繰り返し加力実験結果、現地建設状況調査報告を中心に＞

March 23, 2009
Tokyo, Tsukuba, Jakarta, Bandung, Yogyakarta, Kathmandu,
Islamabad, Peshawar, Istanbul and Ankara

Building Research Institute (BRI)

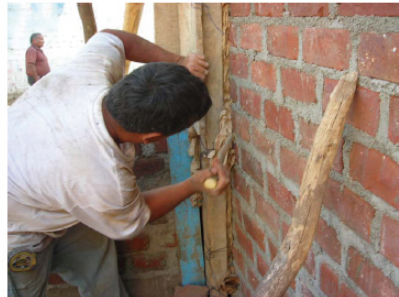
stuffing up the crack of frameworks with paper of cement

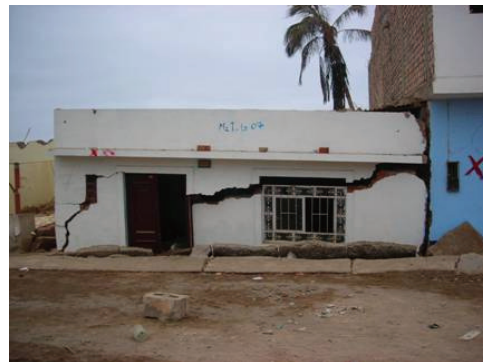
Photo.1 Damage of Near Coast of Central Peru Earthquake of August. 2007

Peru is also prone to earthquakes as Japan. In 2007 “Near Coast of Central Peru Earthquake” caused extensive damage to the Pisco city, where about five hundreds lives were taken for the collapse of the houses. In developing countries, the houses are constructed with little technical intervention (called non-engineered house). To improve seismic safety of the houses, comprehensive construction process is needed. The monitoring activity was carried out in order to grasp the actual condition of the construction works in Peru.

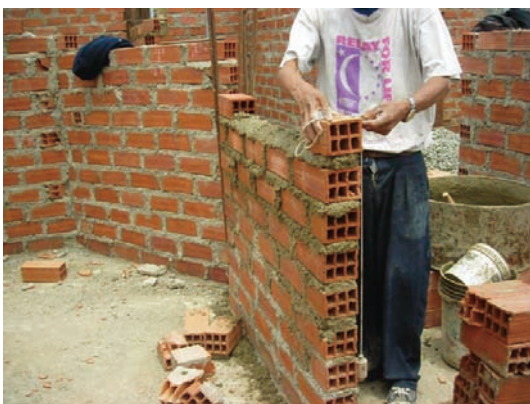
Photo.7. Picture of Neat Laying Work in Villa Salvador

Brick house confined with concrete beam and column is popular in Peru. From the monitoring and interviews with the building workers, it was found that there are several characteristics of Peru's confined masonry work.

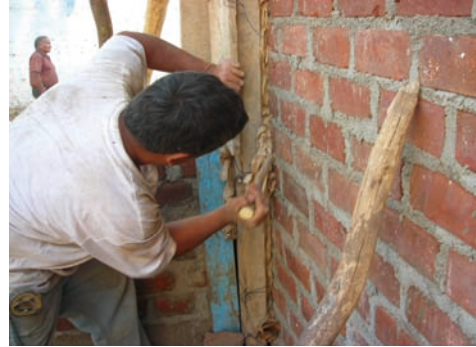
Photo.14. stuffing up the crack of frameworks with paper of cement bag in Caral

1. Quality of concrete;
(e.g. Mixing the concrete directly on the ground Photo.12, Mixing in of foreign materials Photo.14)
2. Lack of concrete covering for steel reinforcement bars (Photo.13,15), sometimes honey comb can be seen; and
3. Lack of steel anchorings in the beam (firm connection) to columns (Photo.15).

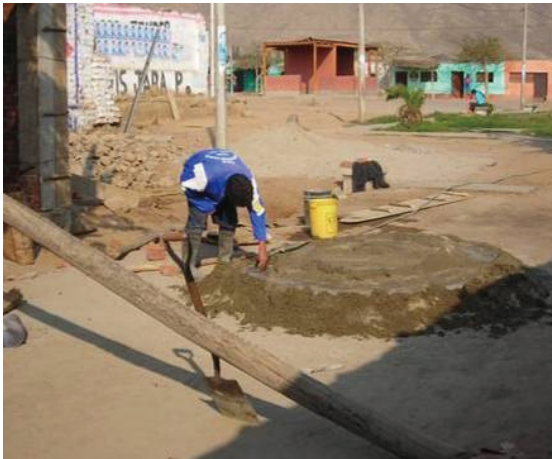
Photo.12. Pouring the concrete on the ground in Caral

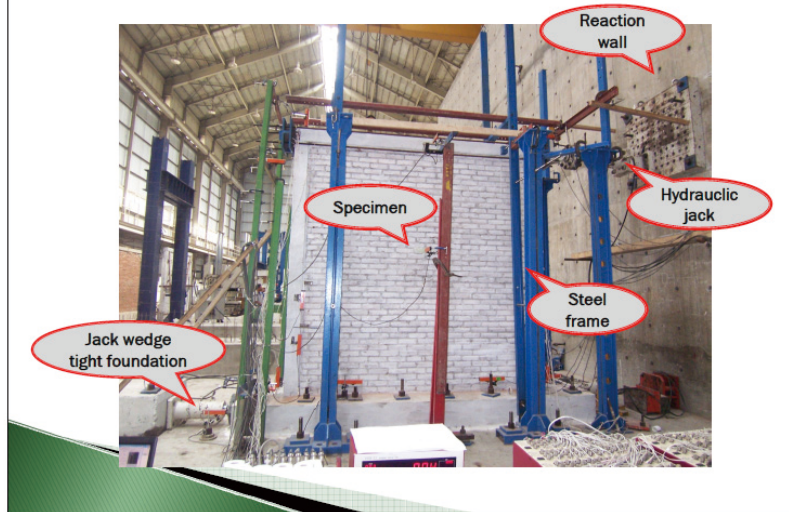
SETUP TESTING RESULT MEASUREMENT

- ▶ lateral and vertical displacement transducers
- ▶ strain gauge FLA 6 x 11 mm² attached on a reinforcing bar

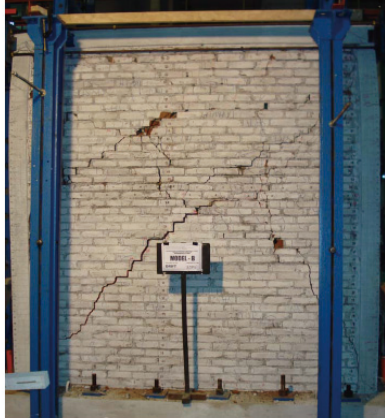
Model B (Benchmark) Damage and Failure Mode

- Crack pattern suggest that Model B is a confined masonry with shear collapse mechanism
- First cracks developed at the wall, and the complete crack pattern shows truss mechanism
- Columns were bent in-plane outwards, allowing some flexural capacity.
- Flexural behavior of columns is limited by the crushing of concrete near the hook and slippage of longitudinal rebars
