8. Damage of Buildings, etc. due to Fire

8.1 Objective of Survey

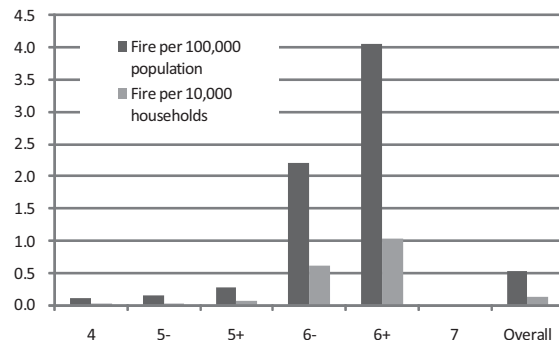
Fig. 8.1-1 Relation between fire break-out ratio and seismic intensity

The relation between seismic intensity and fire break-out ratio in this earthquake is shown in Fig. 8.1-1 and Table 8.1-2. The numbers of fires in some municipalities without seismic intensity data are omitted.

In only one area where seismic intensity 7 was observed, however, no fire was reported. The tendency that the higher the seismic intensity, the higher the fire break-out ratio, is observed in the municipalities where seismic intensity 6 lower (6-) or less was recorded.

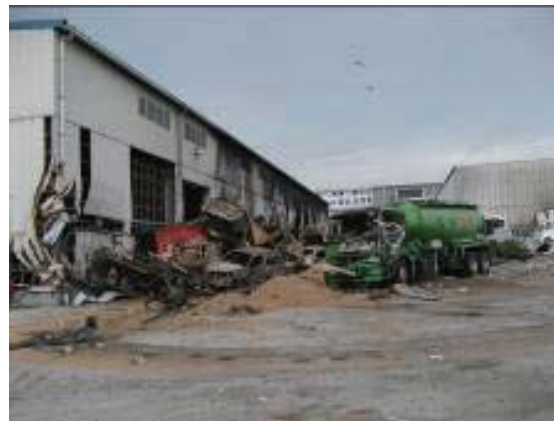
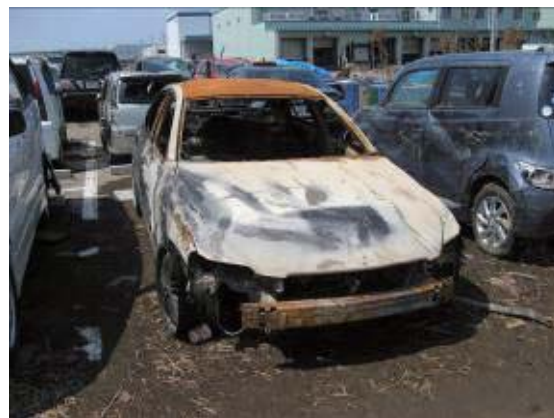
Photo 8.2-2 Tsunami fire at a port warehouse (Sendai city, Miyagi prefecture)

Building at a port was one of the most damaged buildings by tsunami with not only tidal wave but also debris, cars and ships and so forth drifted by tsunami (Photo 8.2-2 and 8.2-3). Several hundred automobiles which have been parked in a parking zone, being drifted to a port warehouse by the tsunami, caused fire at the place where it accumulated.

The cause of the fire is unclear, but it is assumed that the car collided severely each other, the gasoline tank of the cars were damaged, and sparked by malfunction of the electrical system by the seawater. There was no spread of fire in the interior of the building, only the external wall has been damaged by fire.

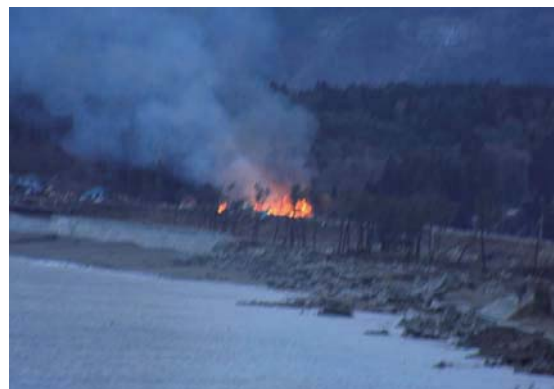
Photo 8.2-4 Fire at a site of 8 buildings due to tsunami (Noda-village, Iwate prefecture), Courtesy of Noda-village

Photo 8.2-4 shows the fire at a coastal village after several hours of tsunami invasion. The fire continued for

over 12 hours. Firefighters could not access to the site because the road had been destroyed by the tsunami.

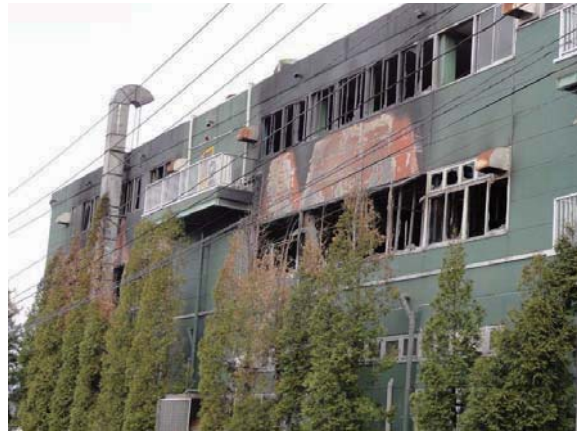
Photo 8.3-2 Fire scene at a factory building (Oushu city, Iwate prefecture)

Photo 8.3-2 shows a factory building fire in which half of the building burned. The cause of the fire is assumed to be ignition by falling of fluorescent light on the ceiling to the floor where the thinner spilled due to earthquake motions by the mainshock.

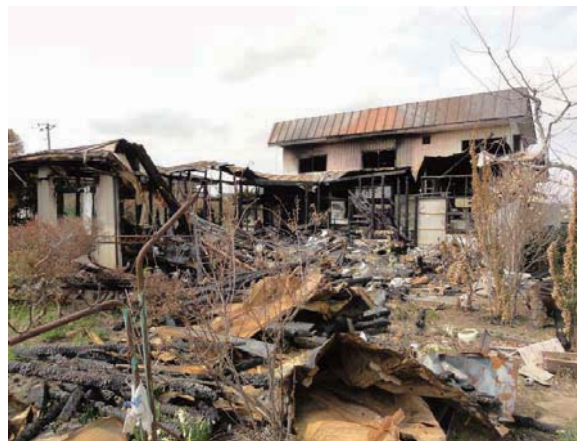
Photo 8.3-3 Fire scene at a house (Oushu city, Iwate prefecture)

Photo 8.3-3 shows another house fire case in which two wooden houses were completely burnt out and three houses were partly burnt. The cause of fire is assumed to be misuse of candlelight for lighting in the midst of power failure on the night of the next day of the mainshock.
