6.2 Damage to Wood Houses

6.2.1 Objectives of damage survey

A lot of wood buildings were damaged by the 2011 Tohoku earthquake. NILIM and BRI surveyed the damage of wood building starting from March 14, three days after the earthquake occurrence for the purpose of grasping the general image of the damage. Because the disaster by the earthquake occurred in wide areas, we carried out the first survey for multiple times, but cannot grasp the whole aspect of the damage. In this chapter, results of these multiple survey were summarized as basic documents to devise a survey plan in afterward to consider about the damage cause.

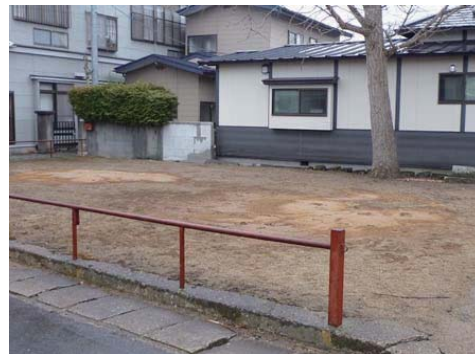
Photo 6.2-2 Sand boil due to liquefaction

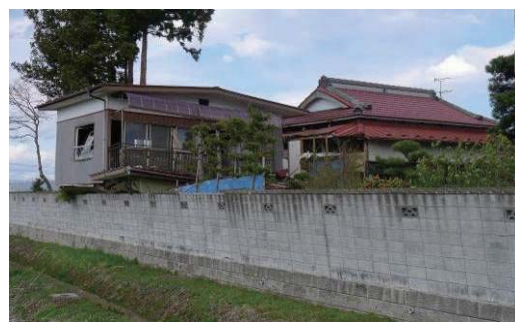
Photo 6.2-24 Collapsed wood house

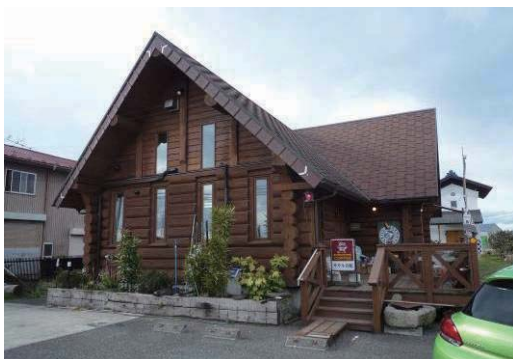
which two-story might have been extended. In the southern side of Eaigawa river, there were log house without damage (Photo 6.2-27), wood house which tilted largely at first story (Photo 6.2-28) and tilted shrine building (Photo 6.2-29).

Photo 6.2-27 Log house without damage

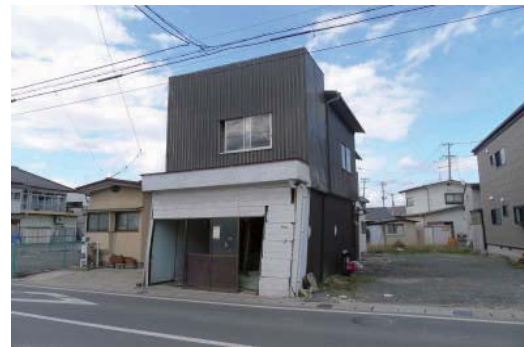
On the both sides of the street, there were collapsed wood house by earthquake (Photo 6.2-35) and tilted wood house with store (Photo 6.2-36). It was estimated that the wood houses with store which have less seismic elements at the first story were heavily damaged.

Photo 6.2-36 Tilted wood house with store

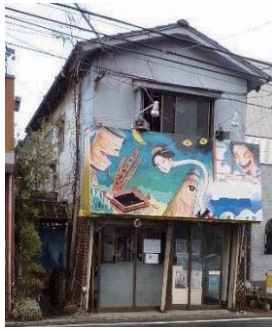
Photo 6.2-41 House with large residual deformation (Komatsujima)

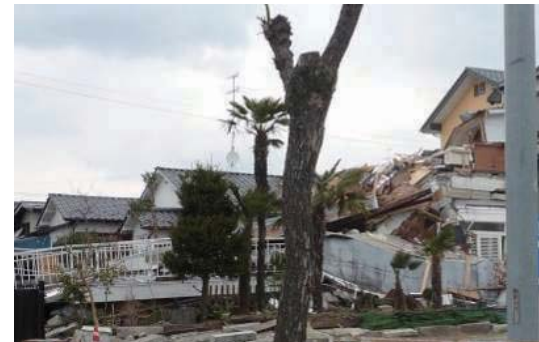
Another collapsed building with uncertain structural type was found (Photo 6.2-53). According to the damage overview seen from the east of Minami-machi (Photo 6.2-54), it was observed that the wood houses with roof covered temporarily with blue vinyl sheet which was guessed to be damaged to roof tiles were relatively many.

Photo 6.2-53 Collapsed building (Unknown structure type)

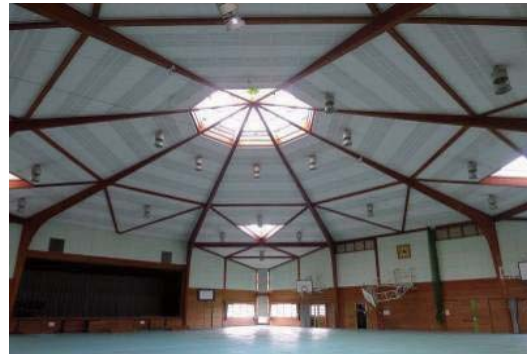
Photo 6.2-77 Inside of the gymnasium

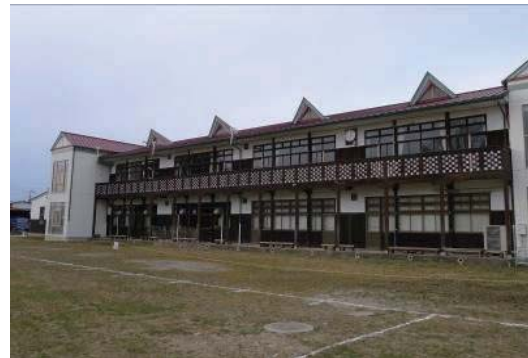
Photo 6.2-79 Wood school building
