9. Response of Seismically Isolated Buildings

9.1 Outline of Surveyed Buildings

9.2 Behavior of Seismically Isolated Buildings

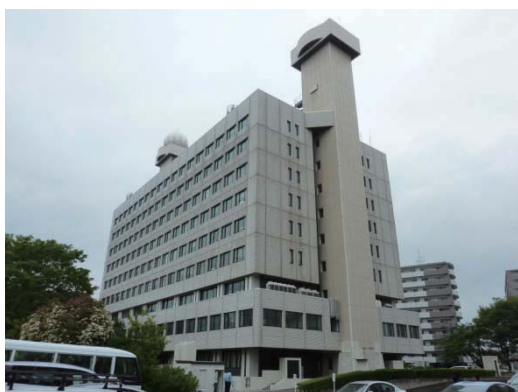
(a) Overview of the building (b) Sign board to warn about seismic gap

The SI building (A) is a steel reinforced concrete office building with 9-story super-structure and 2-story basement, located in Miyagino ward in Sendai city (Photo 9.2-1). The building was retrofitted by using base isolation technique putting isolation devices on the top of columns in B1F. The floor plan has the 26.4 m × 54 m rectangular shape and 44 HRBs are installed.

Photo 9.2-1 SI building (A) – SRC office building –

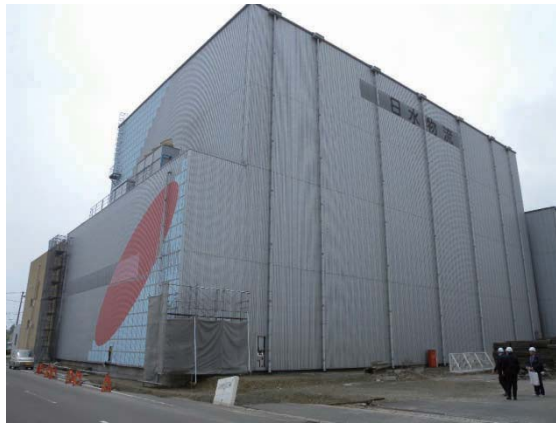
Photo 9.2-5 SI building (B) – Steel warehouse -

The SI building (B) is a one-story steel warehouse constructed in 1996, located in Miyagino ward in Sendai city (Photo 9.2-5). The building height is 30 m. There are 20 HRBs with diameter 850 mm and 4 HRBs with diameter 800 mm arranged in the basement with 51.6 m × 31.7 m rectangular shape.

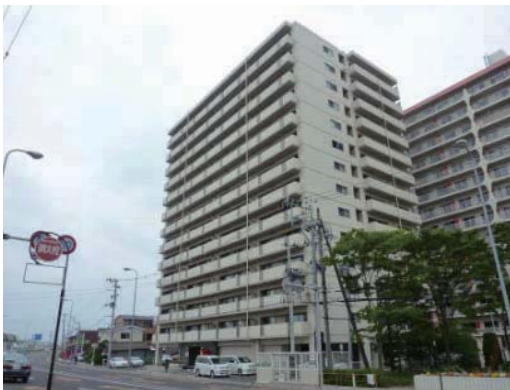
(a) Overview of the building

The SI building (C) is a 14-story reinforced concrete building used for condominium, located in Miyagino ward in Sendai city (Photo 9.2-12). The building has U-shaped plan and corners of the building are separated by expansion joints. There are 24 NRBs, 8 LDs and 13 USDs installed in the SI floor.

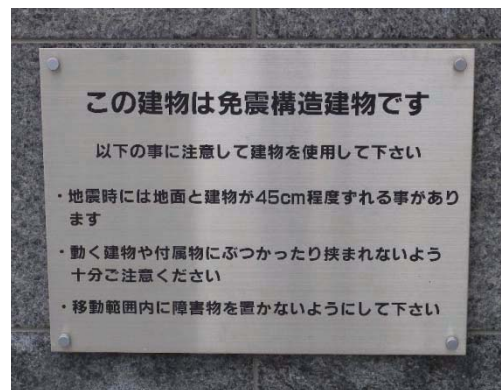
(b) Sign board to warn about seismic gap

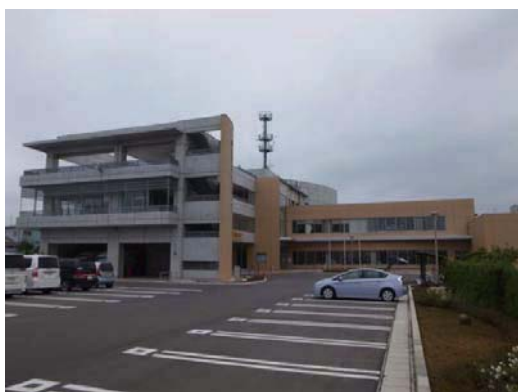
(a) Overview of the building

The SI building (L) is a 3-story reinforced concrete building used for fire station, located in Tome city (Photo 9.2-18). The following SI devices are installed in the basement with L-shaped plan; 61 m in the east-west direction and 58 m in the north-south direction:

Photo 9.2-18 SI building (L) – RC fire station building –

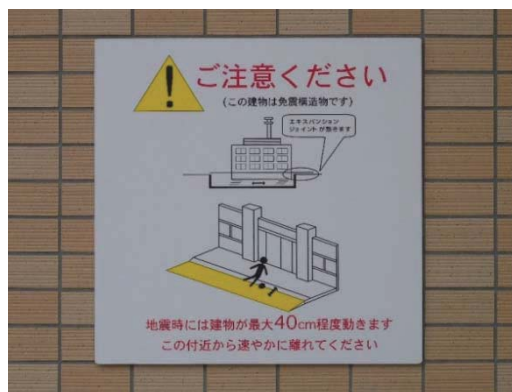
(b) Sign board to warn about seismic gap

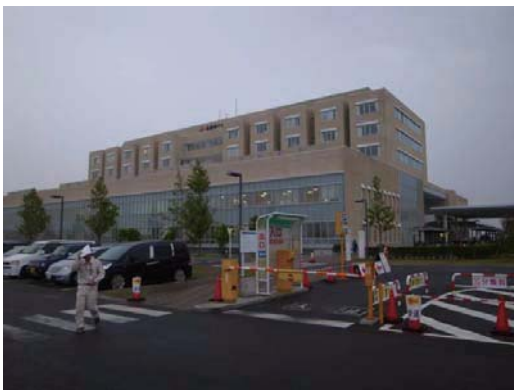
(a) Overview of the building

Photo 9.2-21 SI building (M) – Steel hospital building –

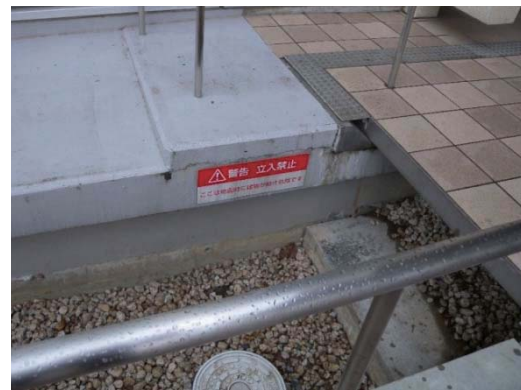
(b) Sign board to warn about seismic gap
