# Improving Fire Safety in Buildings

In last month's column introducing initiatives of Japan's Building Research Institute, we looked at the Institute's efforts to unravel the mystery of wind damage to buildings. In this month's issue we look at the Institute's work to improve the fire-resistance performance of buildings as well as to develop performance regulations for fire control standards based on clarification of fire phenomena.

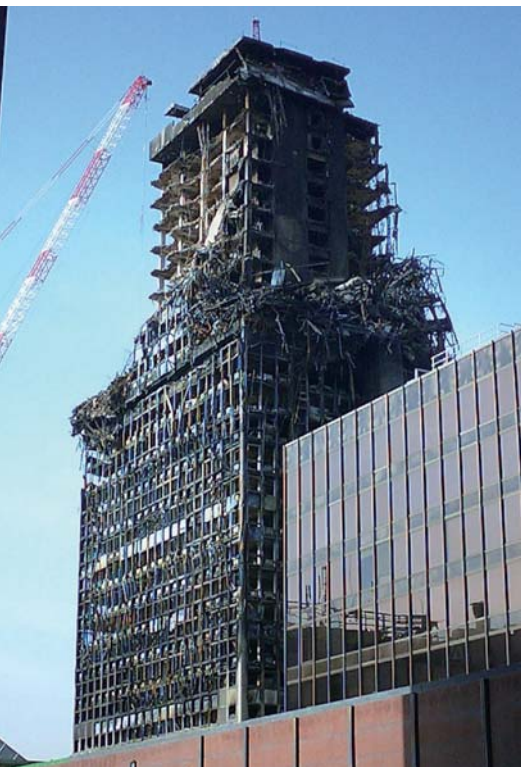
Photo 1: Total destruction of high-rise building in Spain with large-scale collapse of the upper floors

**D**espite starting on the twenty-first floor, a fire in a high-rise building in Spain in February 2005 destroyed almost the whole thirty-two-story tower with widespread collapse of the exterior walls and floors of the upper stories (**photo 1**). Had it been a wooden building, there would have been no wonder about its total destruction and collapse in a fire. However, there are hardly any examples of a high-rise building collapsing in a fire. Since the Building Research Institute had a very strong interest in the collapse of the building as a result of this fire, we organized a field trip to Spain together with Japanese fire

engineers. As a result, we found that due to ongoing refurbishment of fire safety measures, no fire compartments were installed in the building where the fire broke out. Therefore, the fire was able to spread through the gaps in the exterior walls and between the floors to the upper and lower floors in a short time, and it became clear that the columns of the peripheral steel frame lost strength and broke down in the heat of the fire causing the widespread collapse.

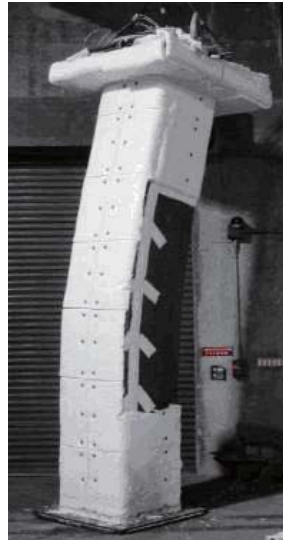
Photo 2: Test column after fire testing where 25% of the fire resistive covering was stripped off

Next, we simulated earthquake damage to the fire protective covering and conducted a test with 25% of the covering removed. As a result of the loss of the insulating effect of the fire protective covering, the fire rating was reduced to a mere 27 minutes. Since the areas without fire protective covering conducted large quantities of heat from direct exposure to the fire, the columns were heated to a high temperature in a short time despite their large size (photo 2).

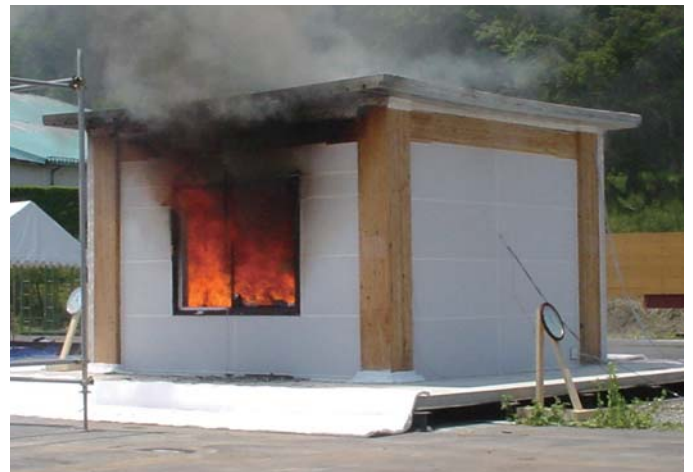
Photo 3: Full-size fire testing of a wooden hybrid construction

We have developed posts and beams with a fire rating of one hour using the Hybrid Timber Member and we have confirmed the performance by conducting fire resistance testing. We also designed a four-story office building using Hybrid Timber Member posts and beams, even erecting a part of the building for full-scale fire testing. As a result of a damage survey after the fire, we were able to confirm that the performance of the post and beam components was identical to the fire resistance test, allowing us to ascertain the fire-resistive performance (**photos 3, 4**).

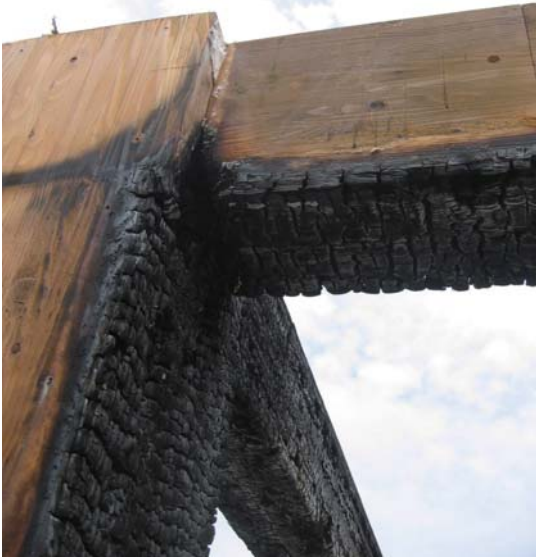
Photo 4: Fire performance after testing

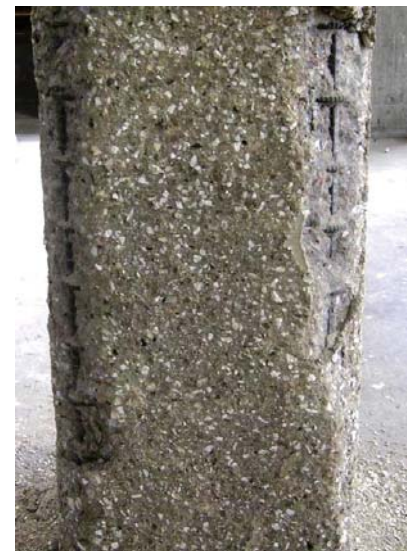
Photo 5: Spalling in concrete components

thought that buildings made of concrete can withstand fire. It is certainly the case that in normal fires, there is only discoloration to the surface of the concrete and there is hardly any structural damage. However, in case of exposure to violent fires burning for a long time, spalling occurs in the surface of the components and damage is caused when portions of the concrete are stripped off. Also, as the surface of concrete was lost and the reinforcing steel became exposed, another problem arose whereby the steel became extremely hot from the heat of the fire. Since buildings are at risk of collapse in a fire if the components are damaged on this scale, it is necessary to prevent spalling of concrete (**photo 5**).
