6.2 Damage to Wood Houses

6.2.1 Objectives of damage survey

A lot of wood buildings were damaged by the 2011 Tohoku earthquake. NILIM and BRI surveyed the damage of wood building starting from March 14, three days after the earthquake occurrence for the purpose of grasping the general image of the damage. Because the disaster by the earthquake occurred in wide areas, we carried out the first survey for multiple times, but cannot grasp the whole aspect of the damage. In this chapter, results of these multiple survey were summarized as basic documents to devise a survey plan in afterward to consider about the damage cause.

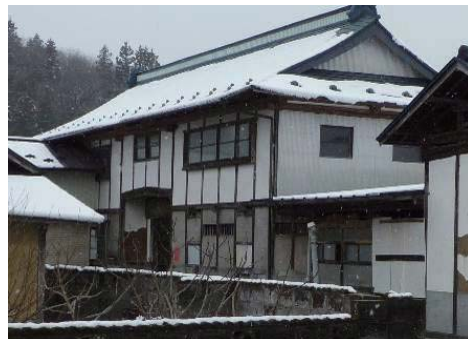
In Kurikomasakurada district, collapse of work hut, drop of the mud plasters of Nagaya-mon gates (Photo 6.2-8), damage of plastered storehouses were observed, but any heavy damage in house was not observed.

Photo 6.2-8 Drop of mud plasters of Nagaya-mon gate (Kurikomasakurada)

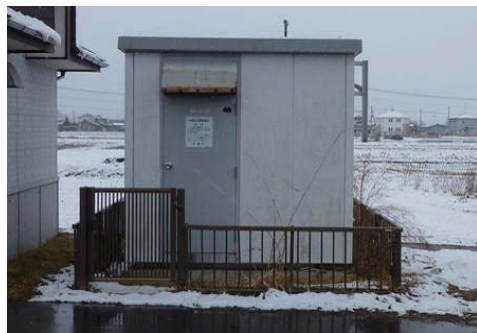
The Seismograph of Kurikoma (JMA seismic intensity 6-) is set up on the parking lot in the west of “Michinoku-Densokan (Photo 6.2-9) ”. From the exterior damage investigation, damage was not observed in “Michinoku-Densokan” and Kurikoma Branch office (Glulam frame structure: Photo 6.2-10).

Photo 6.2-9 Seismograph of Kurikoma

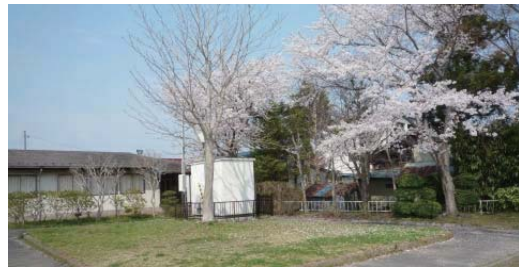
Seismograph at JMA Furukawa (Photo 6.2-16) which recorded seismic intensity 6+ was located in the northeast corner of the Mikkamachi park. There were the former school buildings around it. One of them was not almost damaged (Photo 6.2-17), while the other was damaged on roof tiles and exterior mortar without story drift. In addition to them, a rare damage example (Photo 6.2-18) that only the 2nd story collapsed was observed. On the other hand, a wood school building (Photo 6.2-19) in the west of the Osaki city office seemed not to be damaged in the appearance. Besides these, the house with store with large story drift in 1st story (Photo 6.2-20), those with large story drift in 2nd story (Photo 6.2-21), and 1-story wood house with large story drift caused by the land liquefaction were observed.

Photo 6.2-16 JMA seismic station at Furukawa (Seismic Intensity 6+)

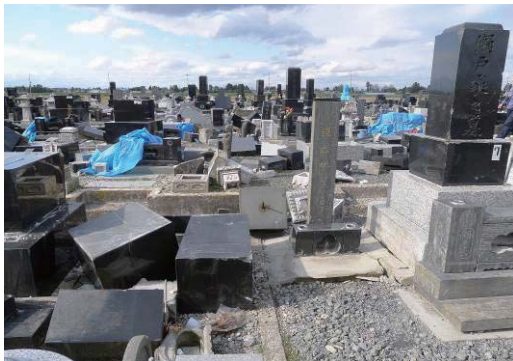
Photo 6.2-25 Tombstones in Hirabari

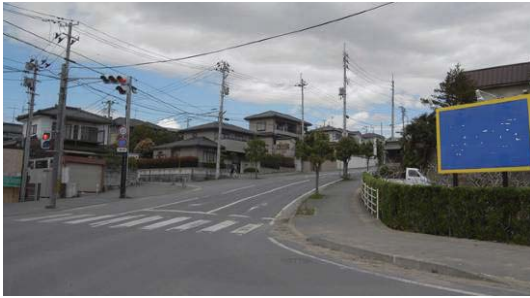
Hiyorigaoka and Izumi-cho in Ishinomaki city are located on a hill (max. Altitude, 56.4m) at the western side of Kyu-kitakami river, almost all of the buildings are residence without public facilities (Photo 6.2-33). There were not heavily damaged wood houses and a few wood houses of which roof tile damaged (Photo 6.2-34).

Photo 6.2-33 Appearance of Izumicho

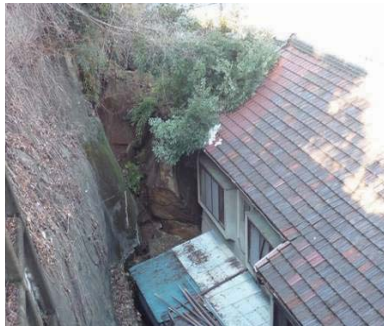
From the results of investigations on Oritate and Seikaen where the damage of the houses were serious, it was found that almost all of the damage of house were caused by ground transformation. Moreover, ground transformation caused retaining wall collapse (Photo 6.2-37, 6.2-38), landslide and damage of houses (Photo 6.2-39). On the other hand, there were some sloping lands in Kaigamori and Asahigaoka where the number of damage of retaining wall was minor, and damage of roof tile, collapse of concrete block wall and outer wall were observed. In Komatsujima, Aoba ward, drop off the mortar wall and damage of columns and biodeterioration by termites were observed in the house with store (Photo 6.2-40). Moreover, the house with large residual deformation on the 1st floor was observed (Photo 6.2-41). In Mukaiyama, Taihaku ward, collapse of a Japanese-style hotel was observed because of the sudden fall of stone of hillback (Photo

Photo 6.2-43 Hillback of the hotel

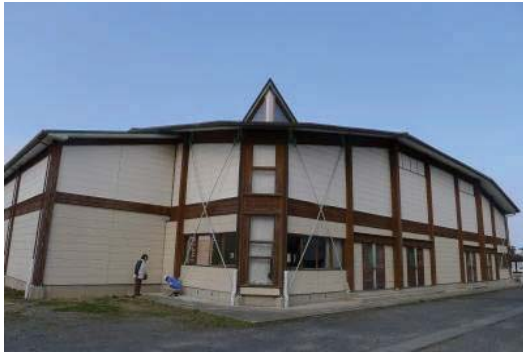
Photo 6.2-76 Wood gymnasium
